# **Report on Study of Electrical Component Corrosion Related to Problem Drywall**

Division of Electrical Engineering  
Directorate for Engineering Sciences  
U.S. Consumer Product Safety Commission

March 2011

## **Report on Accelerated Corrosion Studies of Electrical Components**

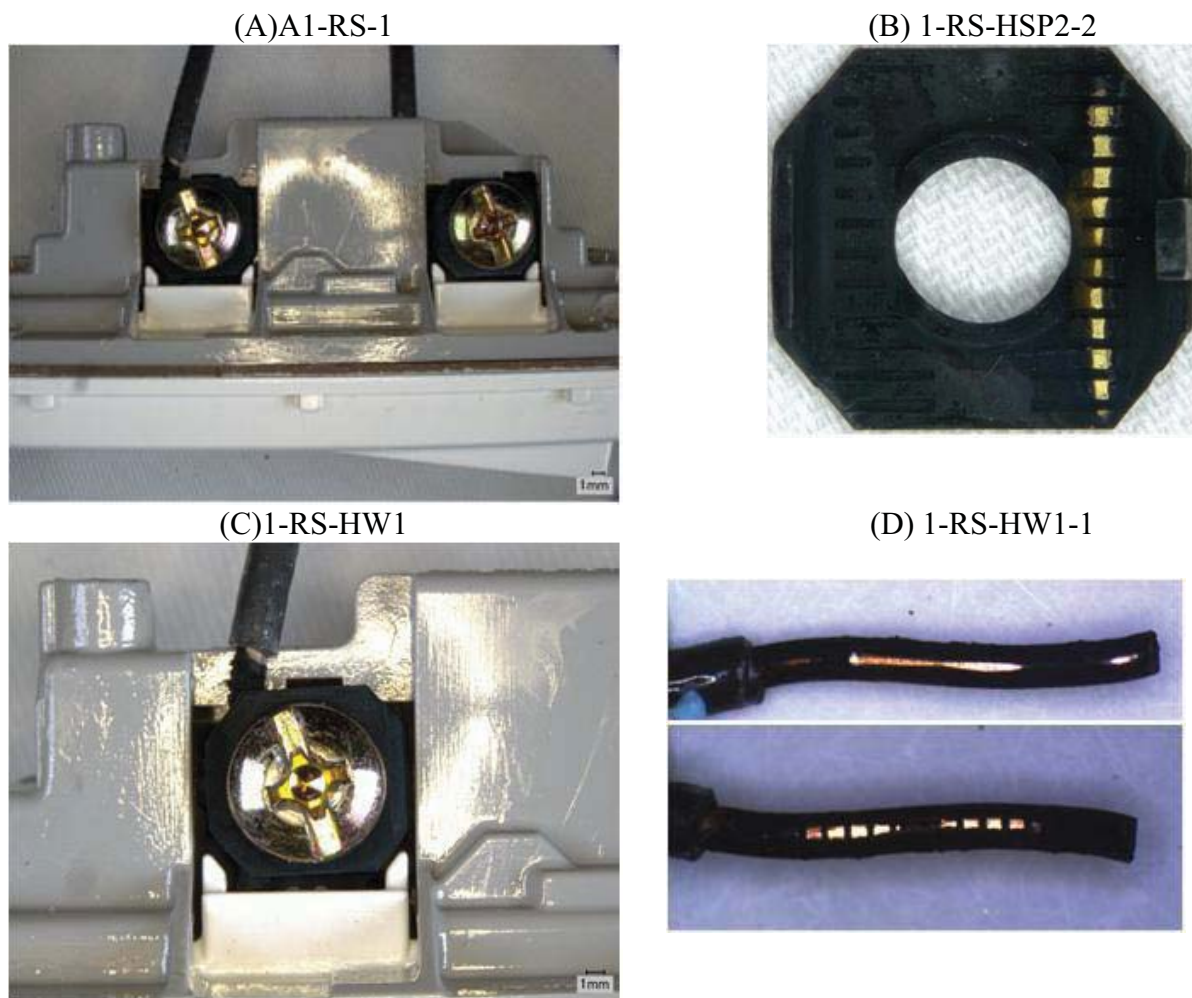
Figure 11 shows macro images for the rocker switch. The image in (A) shows one set of electrical connections to the switch. The image in (B) is of the contact plate under one of the screws. The image in (C) shows a close-up of one of the connections, and (D) shows both sides of the hot wire that was connected to the switch. The black color of the metal parts is the result of the sulfidation process. The contact plate is tarnished completely. Importantly, a row of shiny contact points is visible where the wire contacted the plate. There is a corresponding set of similar features on the wire, where the wire was in intimate contact with the screw. Note that bare metal is visible, indicating that the interface was shielded from the active species in the gas. The screws exhibit less attack. The wire shows considerable corrosion, with “furry” growth observed next to the insulation. Additionally, there is a band of bare metal adjacent to the insulation that appears to have suffered less attack. That is likely the result of slight movement of the wire, exposing fresh surface that had been protected previously by the insulation. This does point out the fact that the insulation shields the underlying metal from exposure to the gas. However, it is also important to note that this accelerated test is designed for boldly exposed metals. It is not designed to accelerate transport of aggressive species through the insulation. Thus, it does not represent 40 years relative to sulfide diffusion and cannot be used to assess the ability of the insulation to protect the wire over a 40-year life.

Figure 11. Optical images from sample 1-RS (rocker switch). The contact plate is shown in B, and one of the hot wires is shown in D (both sides of the same wire are shown). Note the presence of extensive corrosion product on the copper hot wire and contact plate.

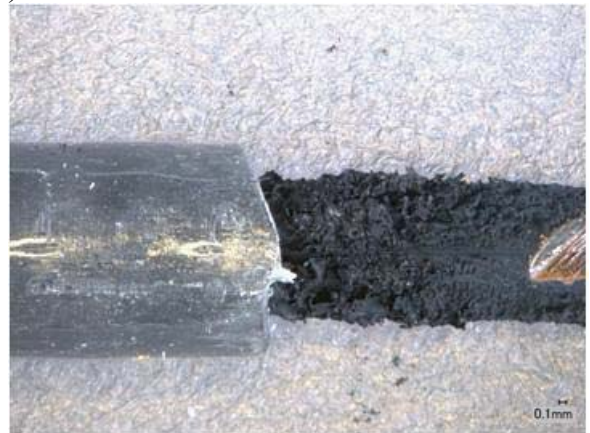
Figure 20. Optical photographs of hot wire removed from receptacle from Circuit 1.

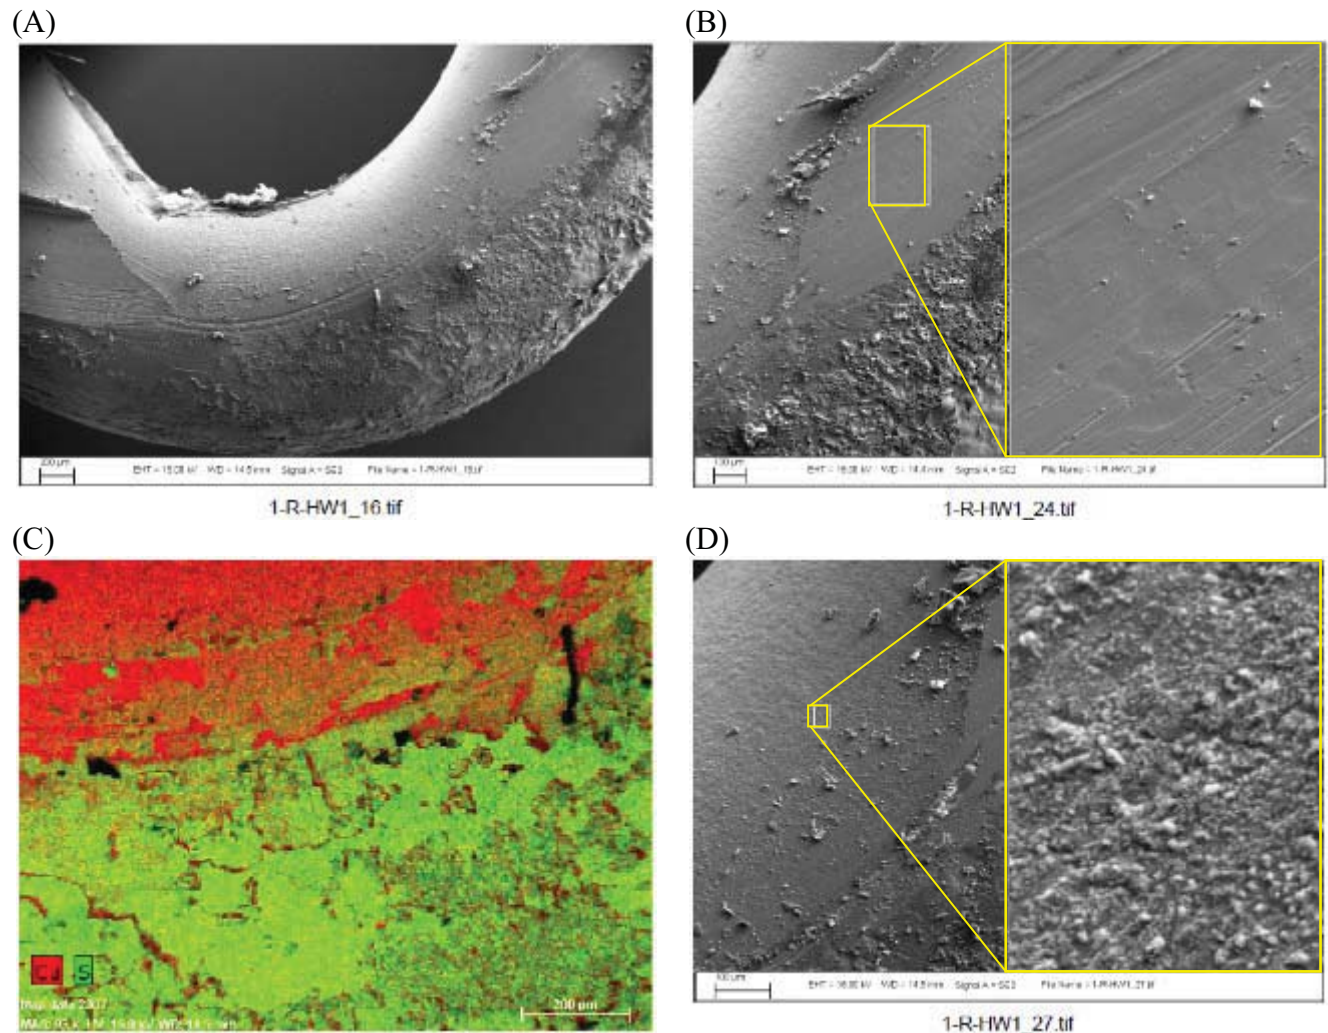
SEM analyses of the hot wire are shown in Figure 21. The location of these analyses is the bend in the wire. Note that the corrosion is significantly more extensive on the outside of the bend. The elemental maps clearly show the difference in corrosion product thickness, clearly a result of shielding the inner portion of the bend from the corrosive gasses.

Figure 21. SEM image (A) of hot wire 1-R-HW1; (B) SEM image of screw contact surface with zoomed area (top right); (C) EDS elemental map showing copper (red) and sulfur (green) distribution; and (D) SEM image ~300  $\mu\text{m}$  from contact (all with 100  $\mu\text{m}$  measurement bars).

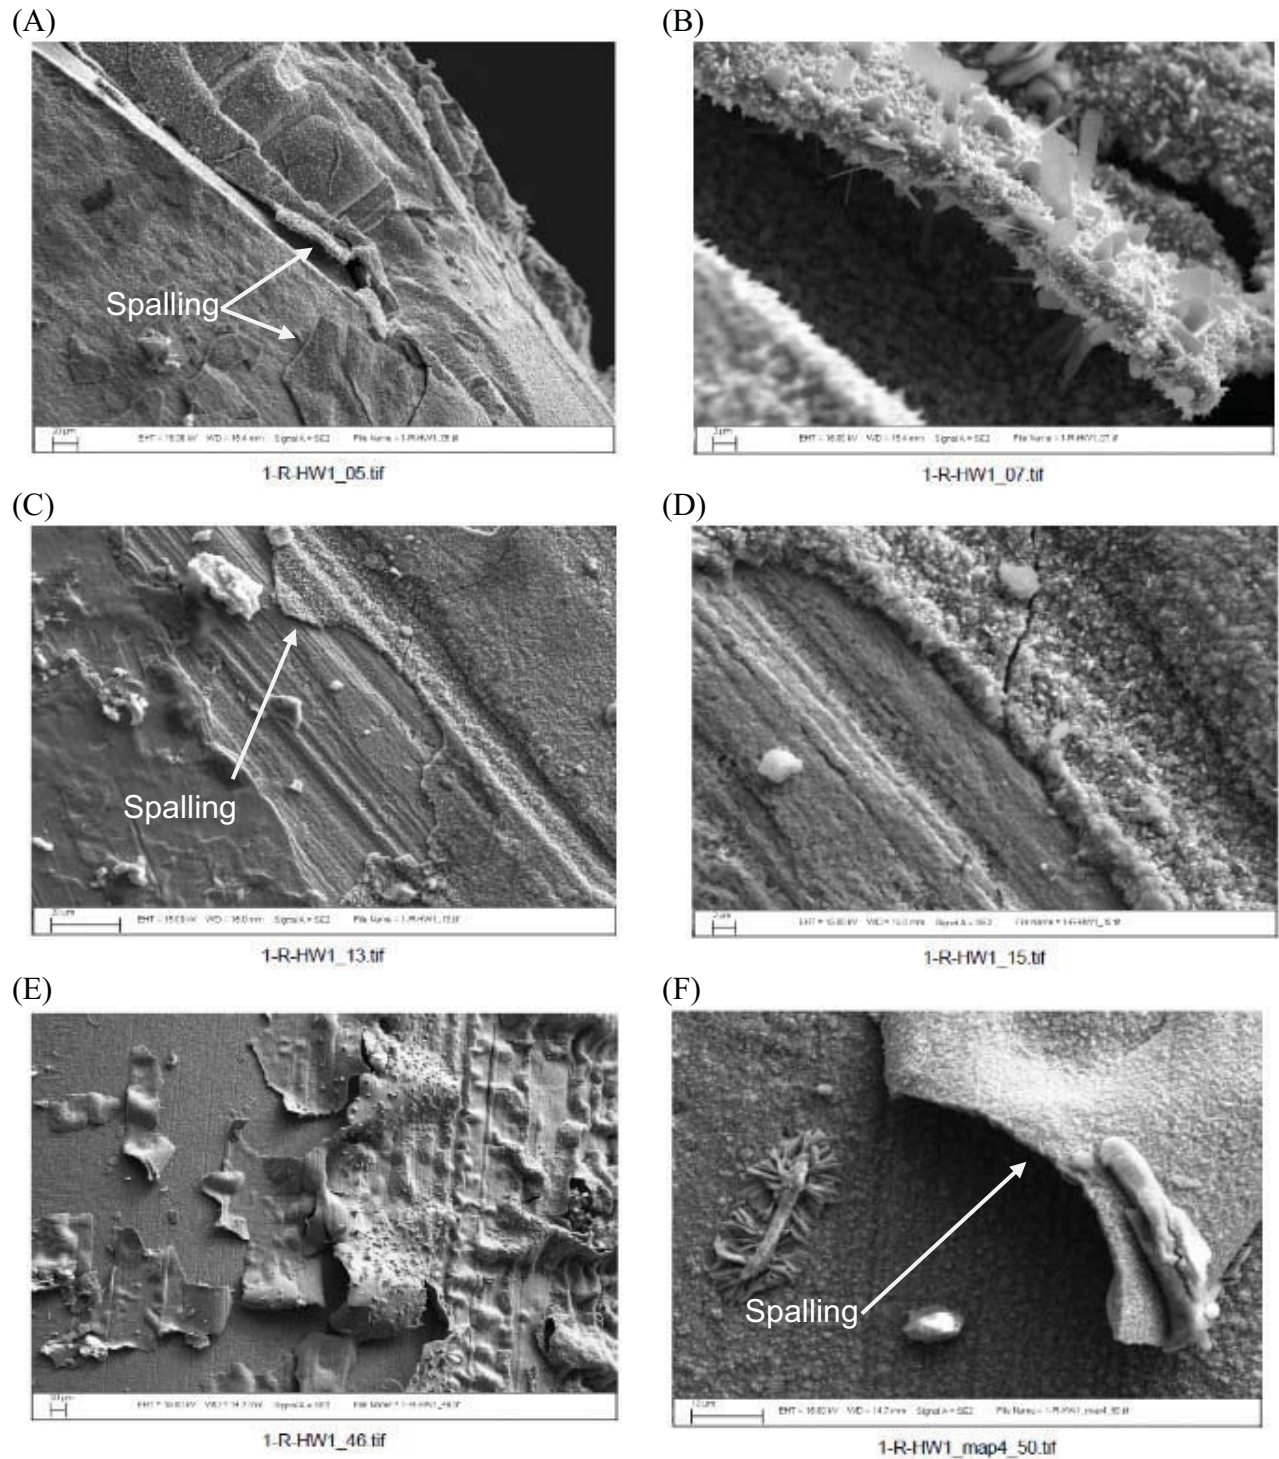
Figure 22 presents SEM images from various locations on the hot wire. Several corrosion product morphologies can be seen. In addition, there is evidence of spalling of the film. Once the film ruptures, it reforms below the previous layer.

Figure 22. SEM images showing the different morphologies of corrosion products on the hot wire from the receptacle in Circuit 1.

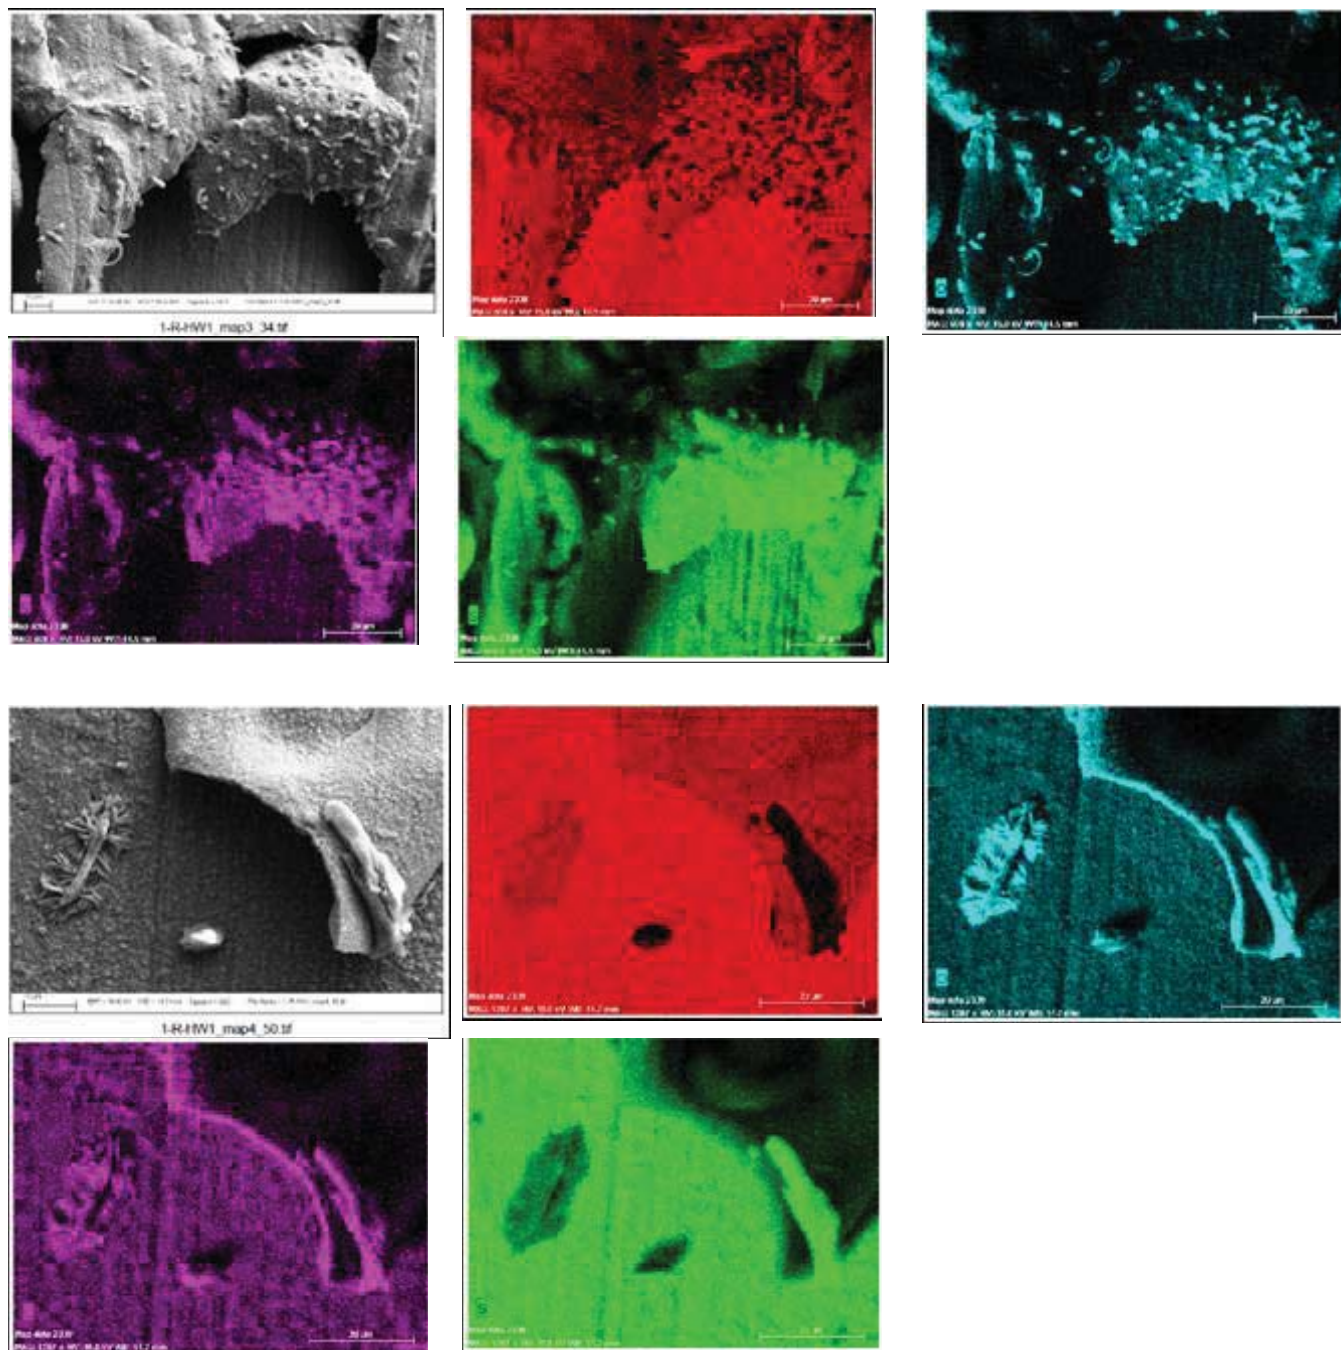
In addition to differences in film morphology across the surface, there is also evidence of differences in film composition. An example is shown in Figure 23. Clearly, certain features are oxygen rich, while others are sulfur-rich. The oxygen-rich features are on the outer surface of the film, and are likely due to oxidation of the surface of the copper sulfide.

Figure 23. SEM images and elemental maps for two areas on wire 1-R-HW-1, showing copper (red), oxygen (blue), carbon (purple), and sulfur (green) distributions.

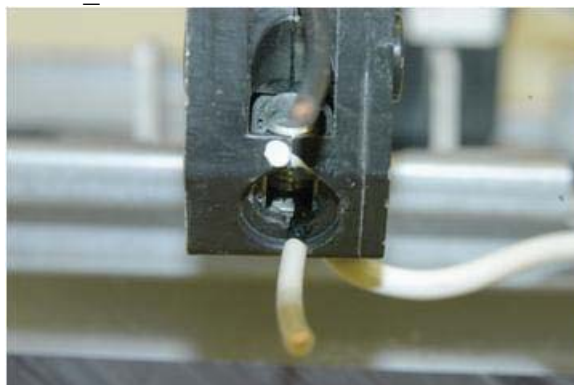
Figure 24. Optical images of the load center and AFCI for Circuit 1.

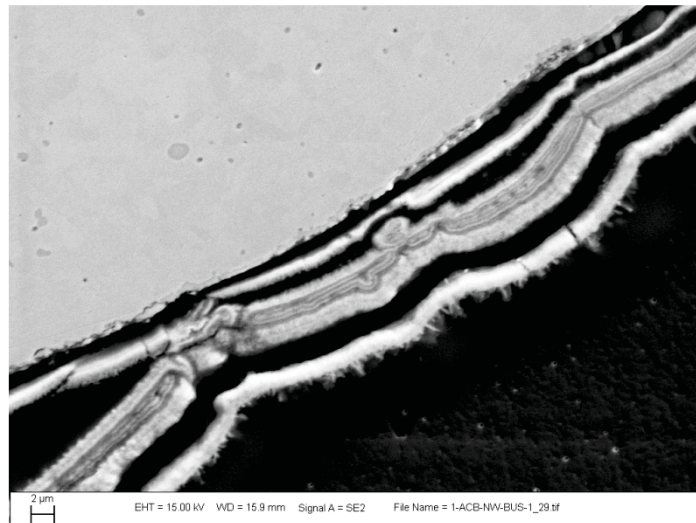
Figure 25. SEM image of the cross section of the neutral wire from the arc-fault circuit breaker from Circuit 1.

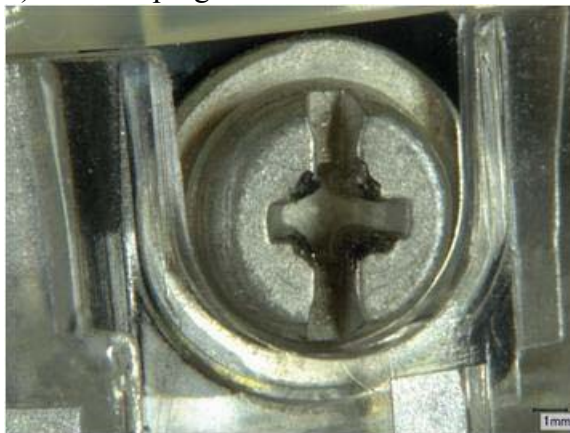
Figure 30. Optical images of the plug used to connect the standard receptacle to the GFCI receptacle in Circuit 1. The prongs and screws are blackened relative to those on a new, as-received, unexposed plug.

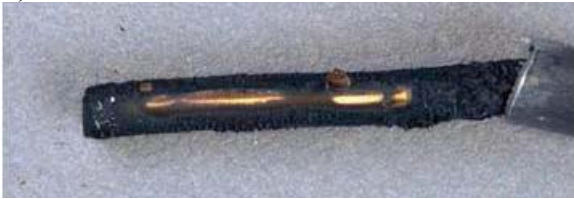
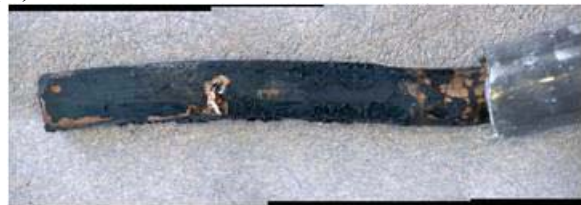
Figure 35. Optical images of wires from the rocker switch in Circuit 2. Both the standard wire connection and the push-in connection are shown.

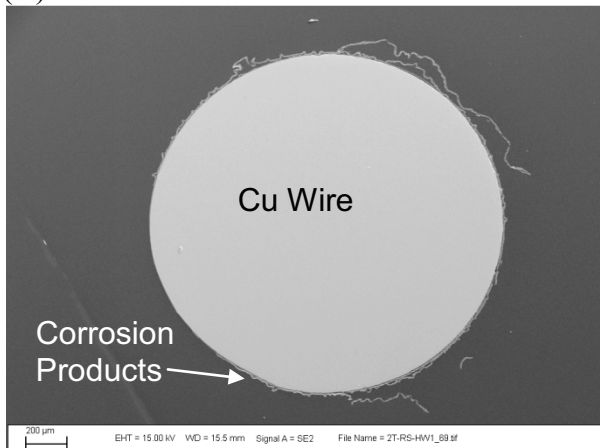
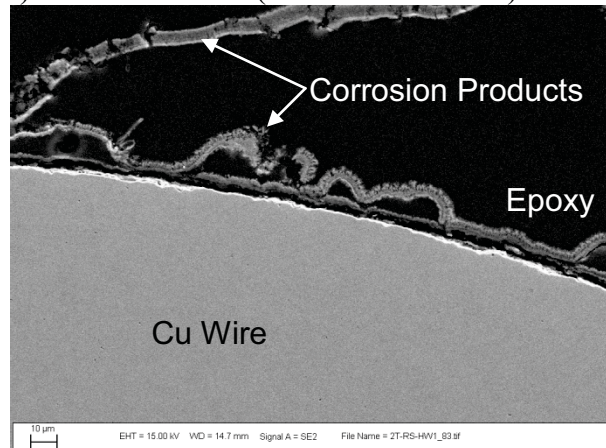
Figure 36. SEM images of the cross section of the rocker switch hot wire from Circuit 2. The image on the left shows a low magnification image of the wire, with a high magnification image showing details of the corrosion product layer presented in the figure on the right.

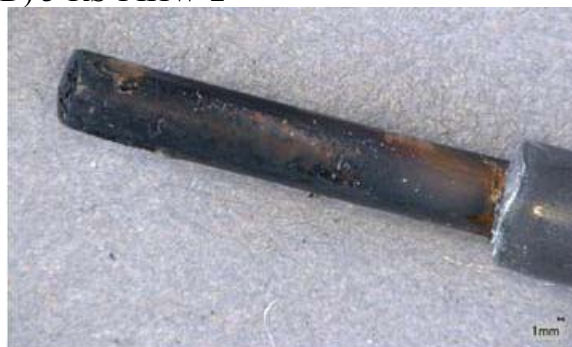
Figure 40. Optical images of the rocker switch and hot wires from Circuit 3.

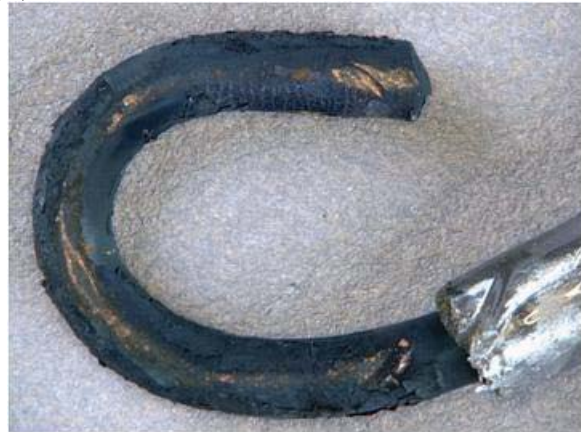
Figure 43. Optical images of the toggle switch in Circuit 3. The figure on the left shows the inside of the switch. Note the extensive corrosion product on some of the components. The image on the right is of the hot wire connected to the toggle switch (screw side).

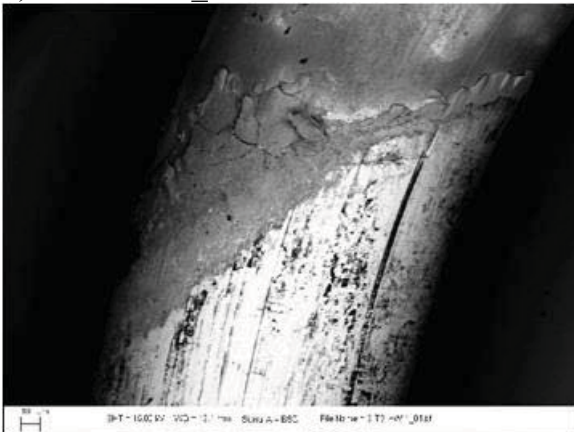
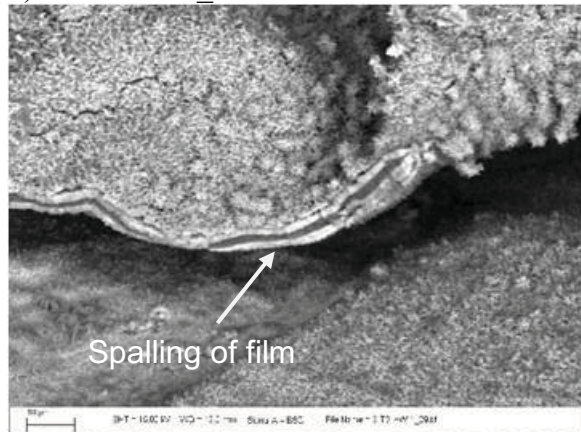
Figure 44. SEM images of the hot wire from the toggle switch in Circuit 3. Note the spalling of the corrosion product film. The contact areas can be seen in the upper two images (bright areas) where the contact shielded the surface from the corrosive gasses.

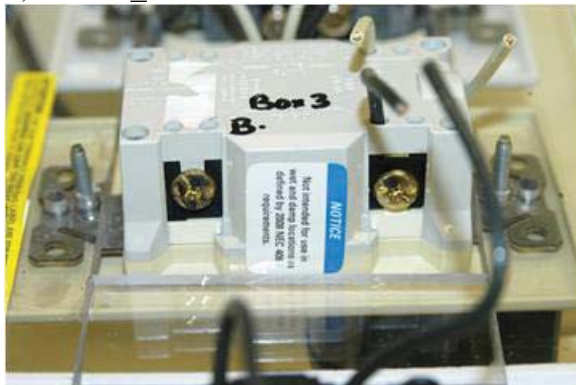
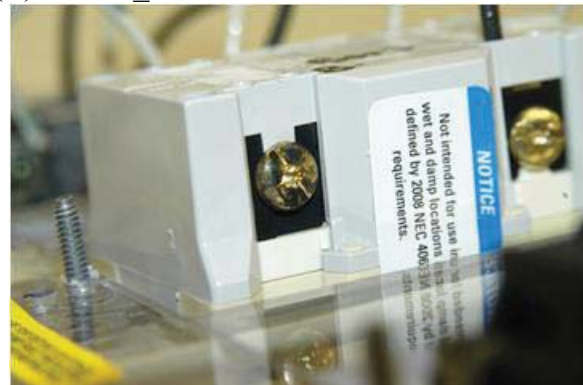
Figure 52. Optical images of the GFCI receptacle. Note the darkening of the normally shiny contact pads and slight corrosion (discoloration) of the screws.

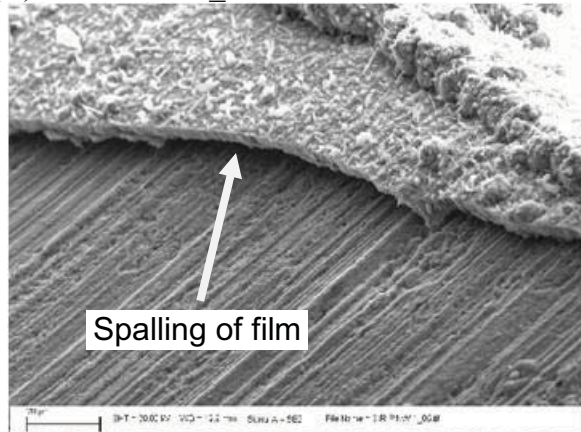
Figure 54. SEM images of the surface of the neutral wire from the receptacle in Circuit 3. The connection was a push-in connection. (B) shows the contact point, which is brighter due to the presence of Cu without S. The end of the wire is shown in the lower images at two magnifications. Note the spalling of the corrosion product film. It is believed that the spalling occurred during the test, but is it possible that it occurred after exposure and prior to analysis.

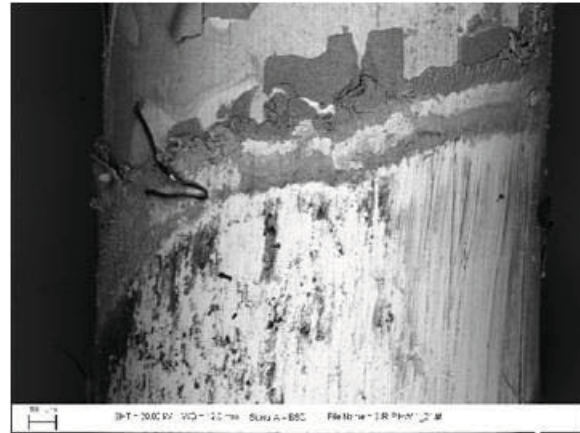
Figure 59. SEM images of the hot wire from the receptacle in Circuit 3. The connection was a push-in connection. The contact point is shown in the image on the left. The image on the right shows a region of a hot wire that was covered by insulation on the bottom.
