# **Report on Study of Electrical Component Corrosion Related to Problem Drywall**

Division of Electrical Engineering  
Directorate for Engineering Sciences  
U.S. Consumer Product Safety Commission

March 2011

## **Report on Accelerated Corrosion Studies of Electrical Components**

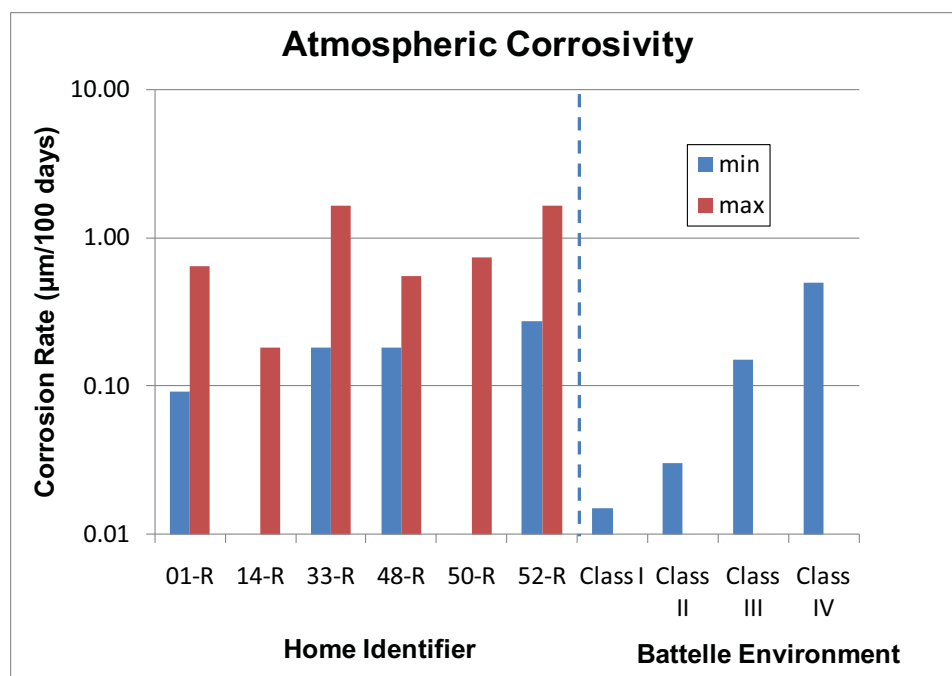
This experiment was designed to test multiple components of a powered electrical system in an environmental chamber in which Battelle Class IV conditions were maintained. The selection of the Class IV environment was based on results from components harvested from several homes. The components were analyzed, and a corrosion product thickness was determined. The exposure was estimated to be three years. Figure 1 presents the data from the harvested components and compares the result to published mixed flowing gas testing. Based on these data, the best fit corrosion class appears to be Class IV, the most extreme corrosive conditions of the Battelle exposure system.

Figure 1. Data from components harvested from homes used to determine the appropriate corrosion class for testing. The data are compared with results from Battelle Class I through Class IV.

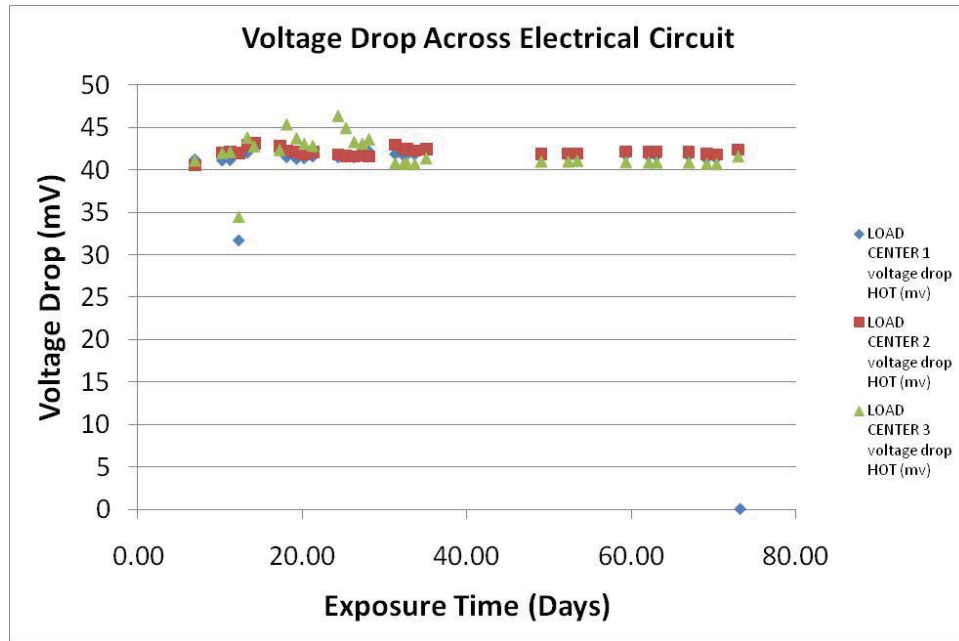
To determine if corrosion products on contacts could lead to resistive heating, measurement points were established to allow the voltage drop across the entire electrical circuit to be measured. Measurements were made several times a week and were taken while the circuit was activated under a 12 A load. Measurements were made with a Keithley 2000 multimeter. Dedicated test points were wired into the circuit (external to the exposure chamber) to allow measurement on a regular basis. Voltage drop data are shown in Figure 8 (hot leg) and Figure 9 (neutral leg). All three of the circuits exhibited essentially identical behavior. The hot leg of the circuit registered about 40 milli-volts and remained constant throughout the test. The neutral leg of the circuit registered about 25 milli-volts and remained constant. The difference is due likely to the smaller number of components with neutral wire connections (both switches and the standard circuit breaker used only hot wire connections). The small magnitude of the voltage drop suggests that resistive heating—due to the presence of corrosion products—should not be a concern.

Figure 8. Voltage measurements made along the length of the ungrounded conductor (hot leg) for each of the three circuits, which included the load center and all the electrical components.

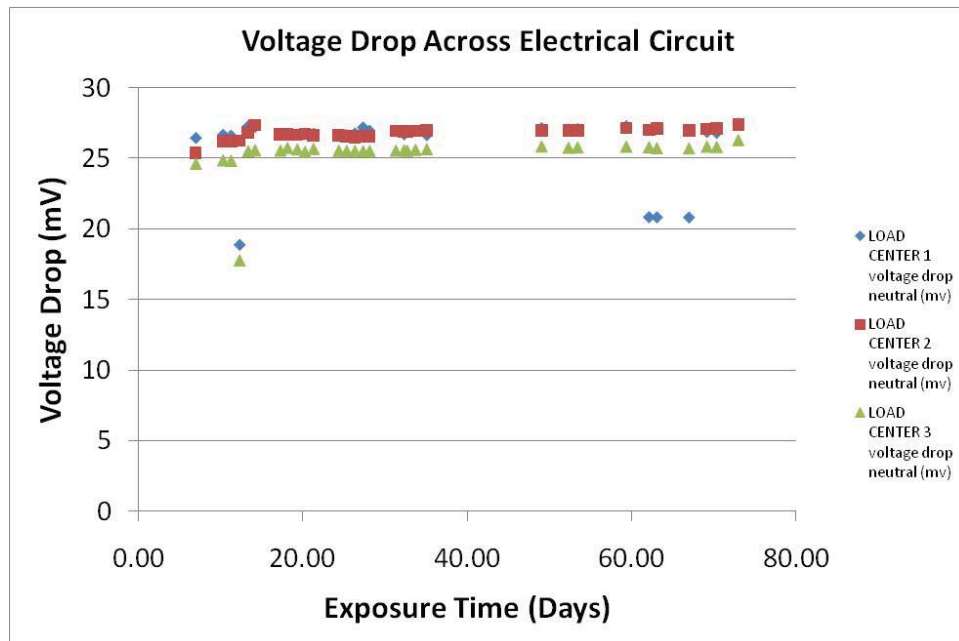
Figure 9. Voltage measurements made along the length of the grounded conductor (neutral leg) for each of the three circuits. Circuits included the load center and all of the electrical components.

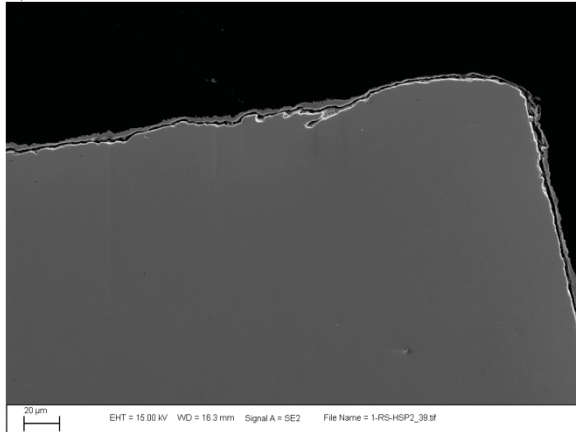
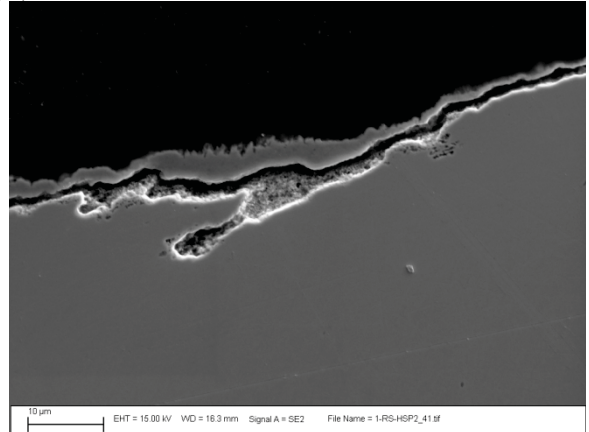
Part	Figure Number	Comments	Thickness (microns)
1-RS-HSP2	Figure 12, Figure 13	Void below corrosion film. Measure depth from perpendicular	15.3
1-RS-HSP2	Not shown		12
1-RS-HSP2	Not shown	At inside curvature of part	36.6
1-RS-HSP2	Not shown	Separation of outer layer, possible fill underneath	52
1-RS-HSP2	Not shown	Wide view with layers and pits	25

Figure 12 shows SEM images of a cross section of the hot screw plate from the rocker switch. Figure 13 and 14 present the elemental data obtained from EDS analysis of the cross section shown in Figure 12. In Figure 13A, a thin layer of corrosion product is visible on the surface of the contact plate. There is evidence of voids below the corrosion product layer, consistent with the sulfidation process. The elemental maps also show Cu and Zn (Figure 13C-D), elemental constituents of the substrate (brass). The sulfide layer is clearly visible on the surface. As seen in Figure 14, the corrosion product layer also contains chlorine and oxygen.

Figure 12. SEM cross section of the hot screw plate (HSP2) from the rocker switch in Circuit No. 1.

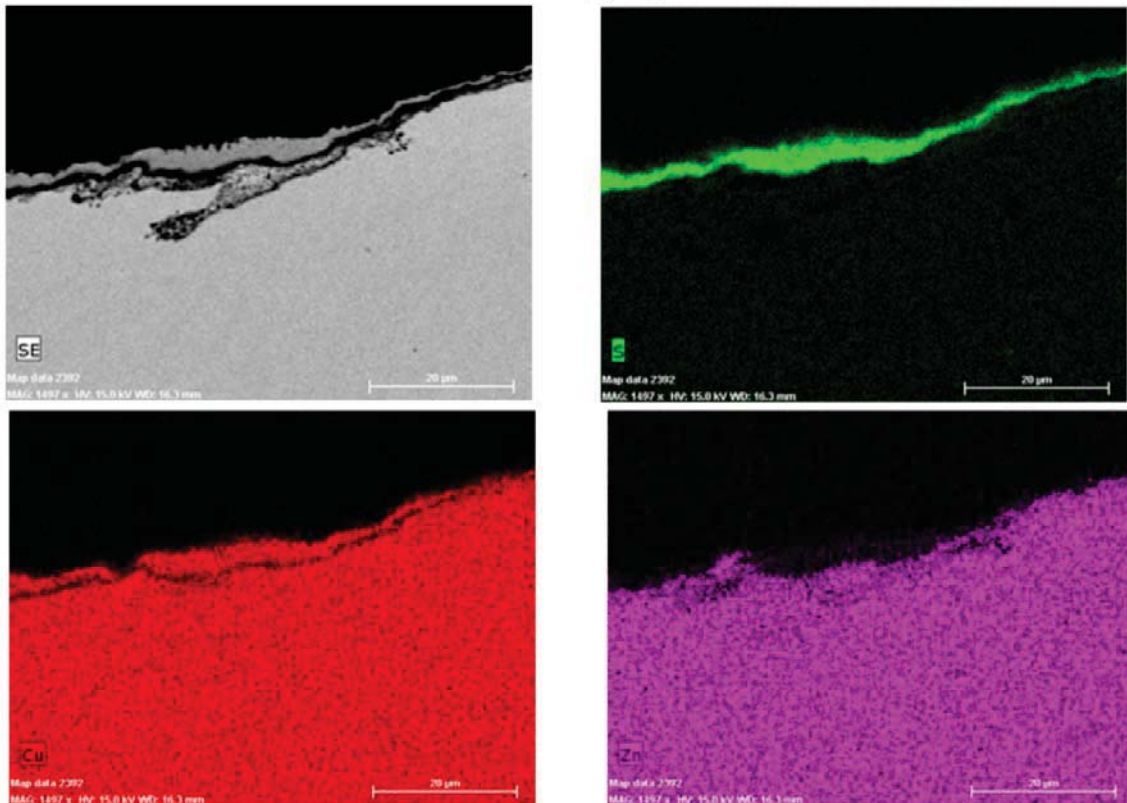
1-RS-HSP2\_map1

Figure 13. SEM image (top left) and elemental maps using EDS of HSP2: sulfur (green), Cu (red), and Zn (purple).

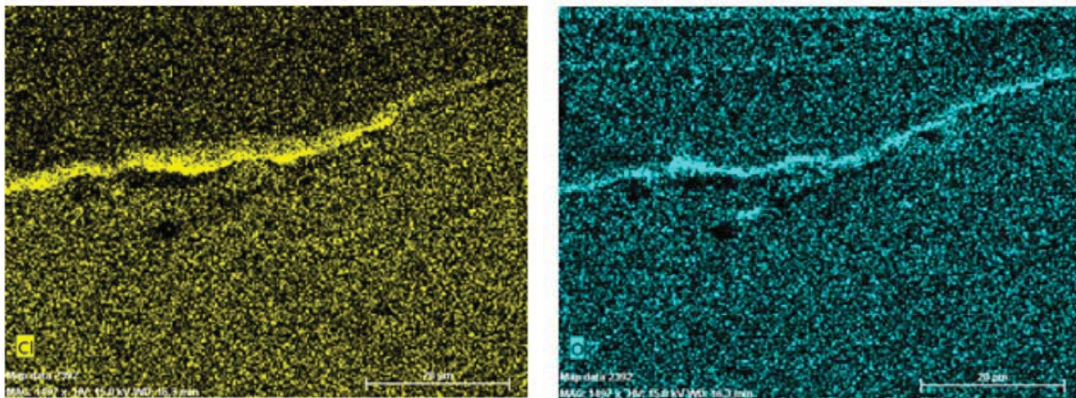
Figure 14. Elemental maps using EDS of HSP2, showing chloride (yellow), and oxygen (blue).

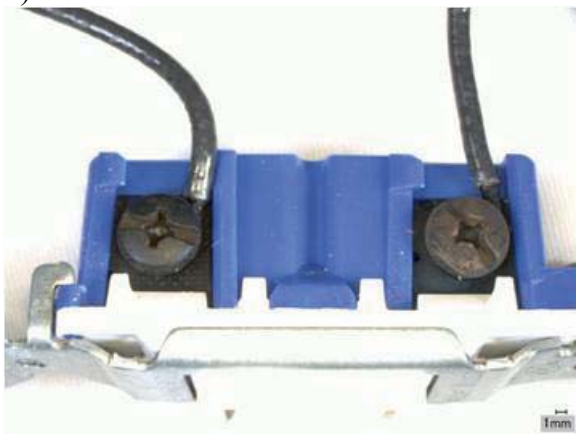
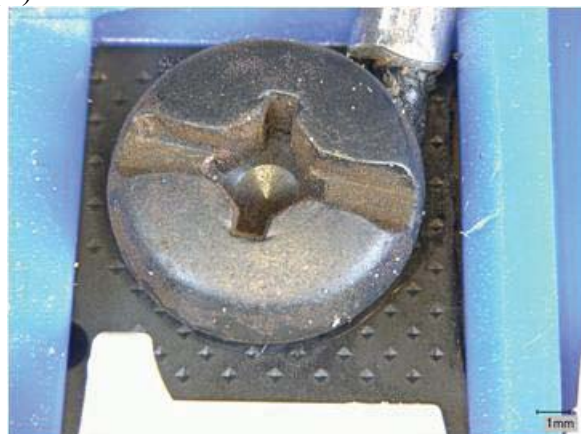
Figure 15 shows optical images of the toggle switch from Circuit 1. The metal contact surfaces exhibit sulfidation. Tarnishing of the wires, contact plates, and screws was observed.

Figure 15. Photographs of toggle switch from Circuit 1.

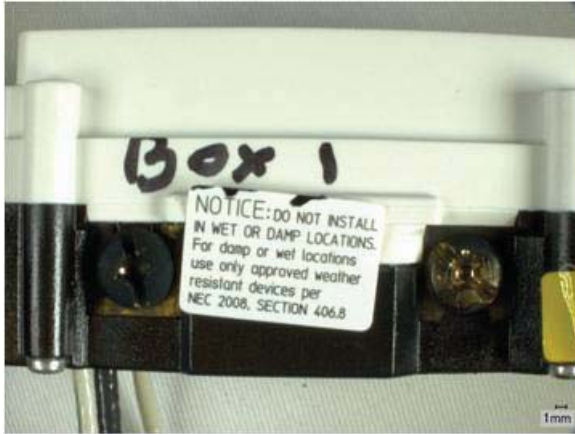
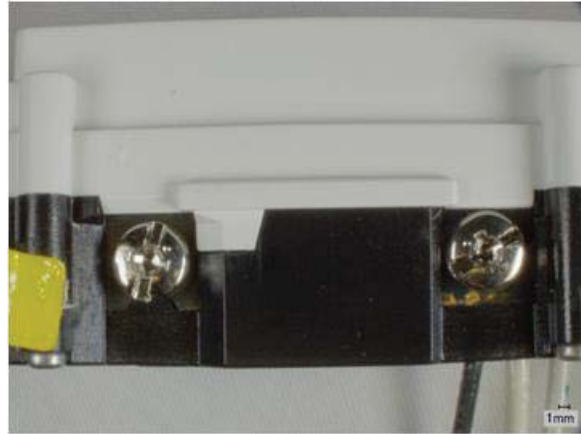
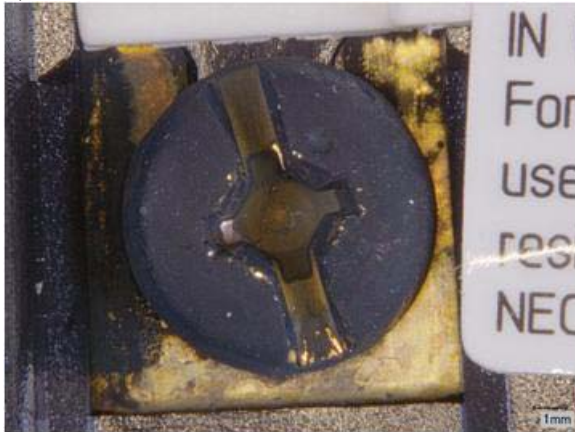
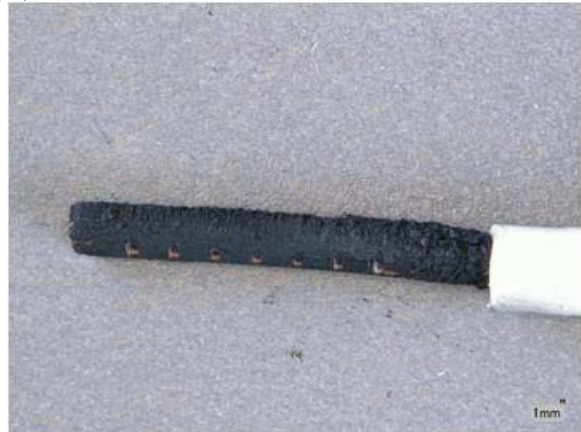
Optical images of the GFCI receptacle from Circuit 1 are given in Figure 16 and Figure 17. Corrosion of the contact surfaces was observed. The screws presented in (B) do not exhibit significant attack. Their color indicates that they are not brass screws, so they are considerably more resistant to sulfidation. Interestingly, the push-in wire (D) exhibits the presence of an extensive layer of corrosion product. This indicates that the gas permeated the receptacle itself. This is supported by the images in Figure 17, which show the insides of the GFCI. Clearly, the receptacle case presents little or no impediment to the corrosion gas. It is interesting to note that many of the internal components were corroded during this test (Figure 17D). Note that the majority of the contact is tarnished, with the real contact area (the spot near the center) exhibiting considerably less corrosion. During the test, one of the load lamps arced, resulting in tripping of

Figure 16. Photos of outside of GFCI receptacle from Circuit 1.

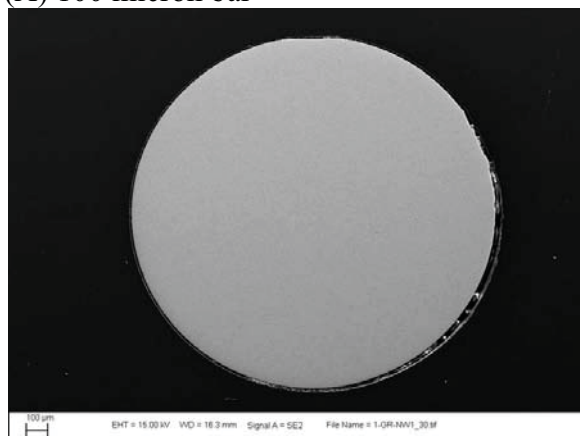
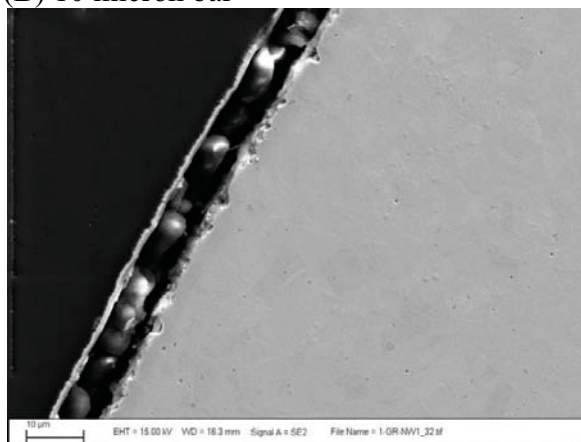
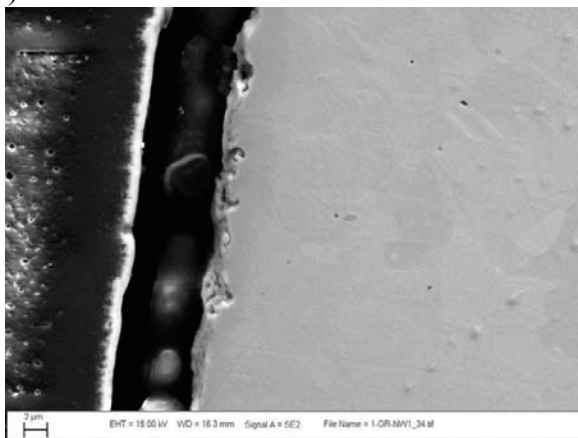
The neutral wire from the GFCI receptacle was cross sectioned for analysis. The SEM images are shown in Figure 18. A thin corrosion product layer can be seen covering the wire surface. A very conservative estimate of the decrease in cross section of the wire can be calculated based on the SEM images. As given in Table 2, the corrosion product thickness was 11 microns. If we assume that the thickness is uniform, and that the corrosion product thickness equals the loss of metal, the cross sectional area of the wire at the conclusion of the test is 98% of the original cross section. In reality, the area decrease is considerably less (the corrosion product thickness is less than the thickness of lost). Thus, attack of the wire did not result in a significant decrease in cross sectional area and does not affect the current carrying capabilities of the wire.

Figure 18. SEM images of cross section of neutral wire 1-GR-NW1.

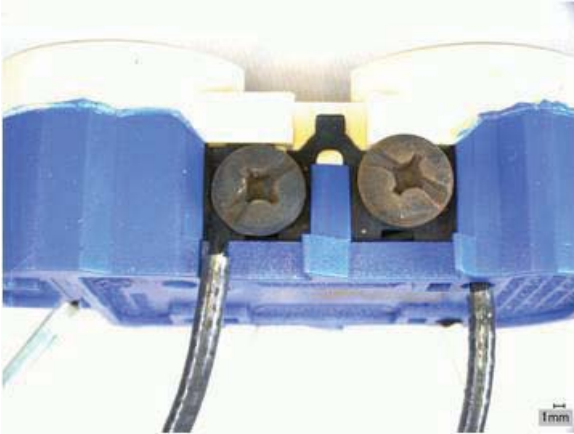
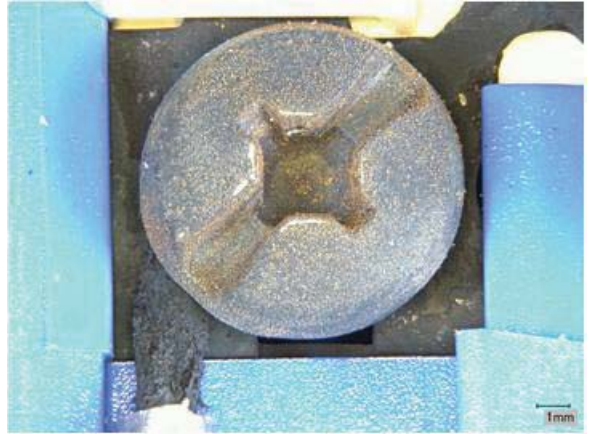
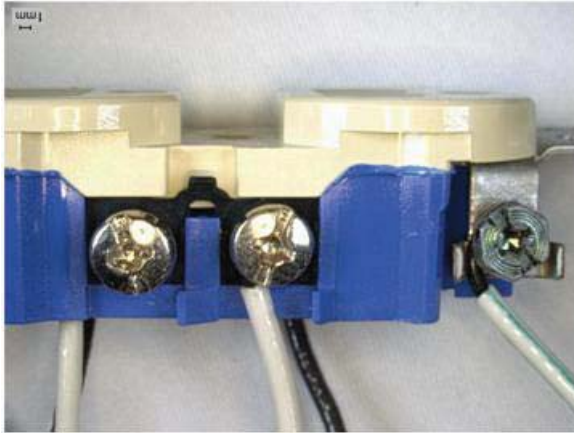
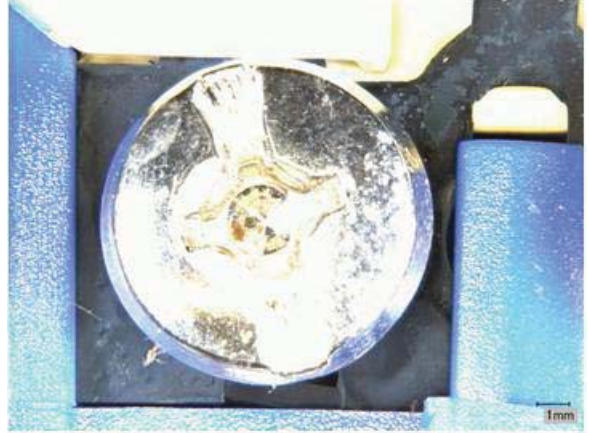
Analysis of the receptacle from Circuit 1 included optical images and SEM analysis of the hot wire. Optical images are presented in Figure 19 and Figure 20. They show corrosion of the Cu base materials. Very little attack of the neutral screws or the ground screw was observed. The wires exhibited significant attack, but were essentially untouched in two locations: where the wire was in intimate contact with screws, and where the wire contacted the pressure plate.

Figure 19. Optical photographs of receptacle from Circuit 1. The image in (A) shows the side view of hot wires; (B) hot screw and contact plate; (C) side view of neutral wires; and (D) neutral screw and contact plate.

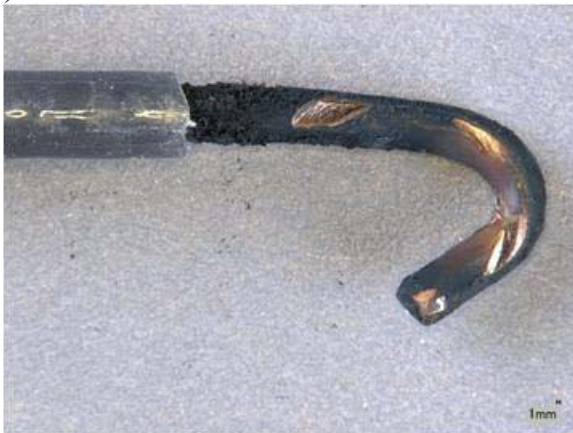
(A) 1-R-HW1-1

Figure 20. Optical photographs of hot wire removed from receptacle from Circuit 1.

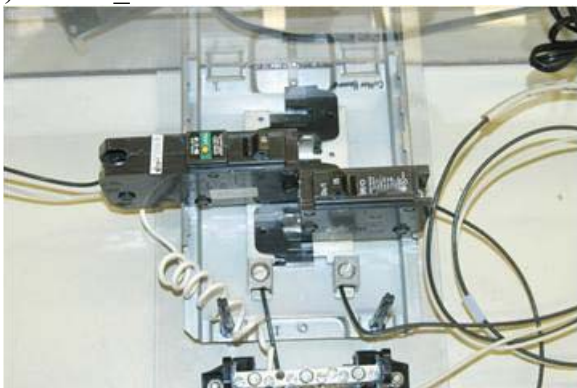
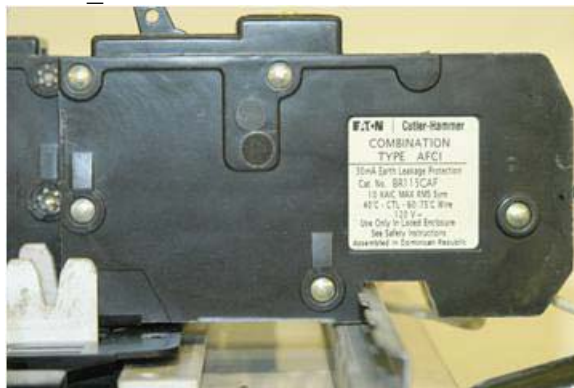
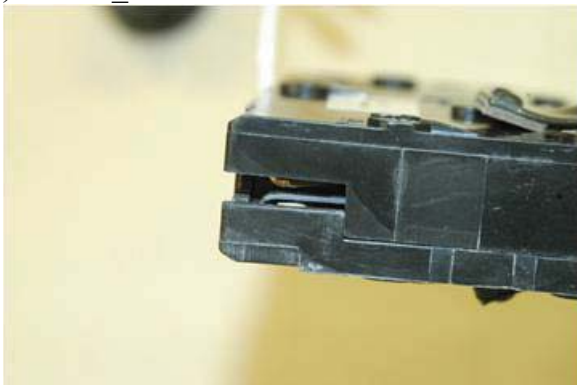
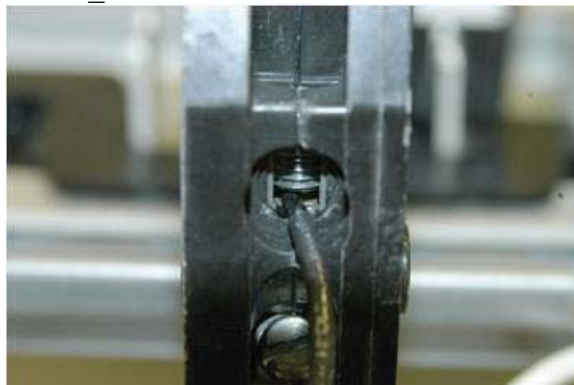
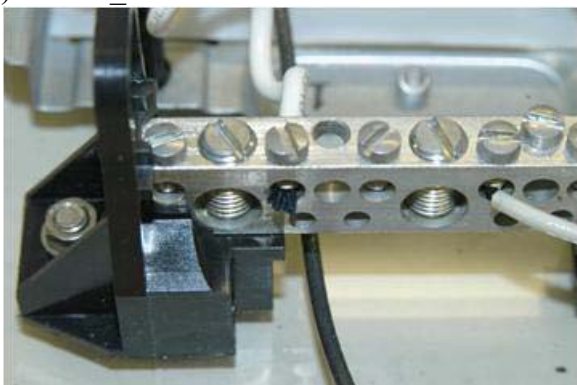
Figure 24 shows optical images of the AFCI from Circuit 1. The output from the standard circuit breaker provides the input to the AFCI. In addition, the neutral feed is connected to the neutral input, and the neutral sense wire is connected to the load center bus. Sulfidation of the contact surfaces can be seen. Both the neutral and hot wires exhibit corrosion, as well as the stranded neutral sense wire (where it is connected to the load center bus—lower left image).

Figure 24. Optical images of the load center and AFCI for Circuit 1.

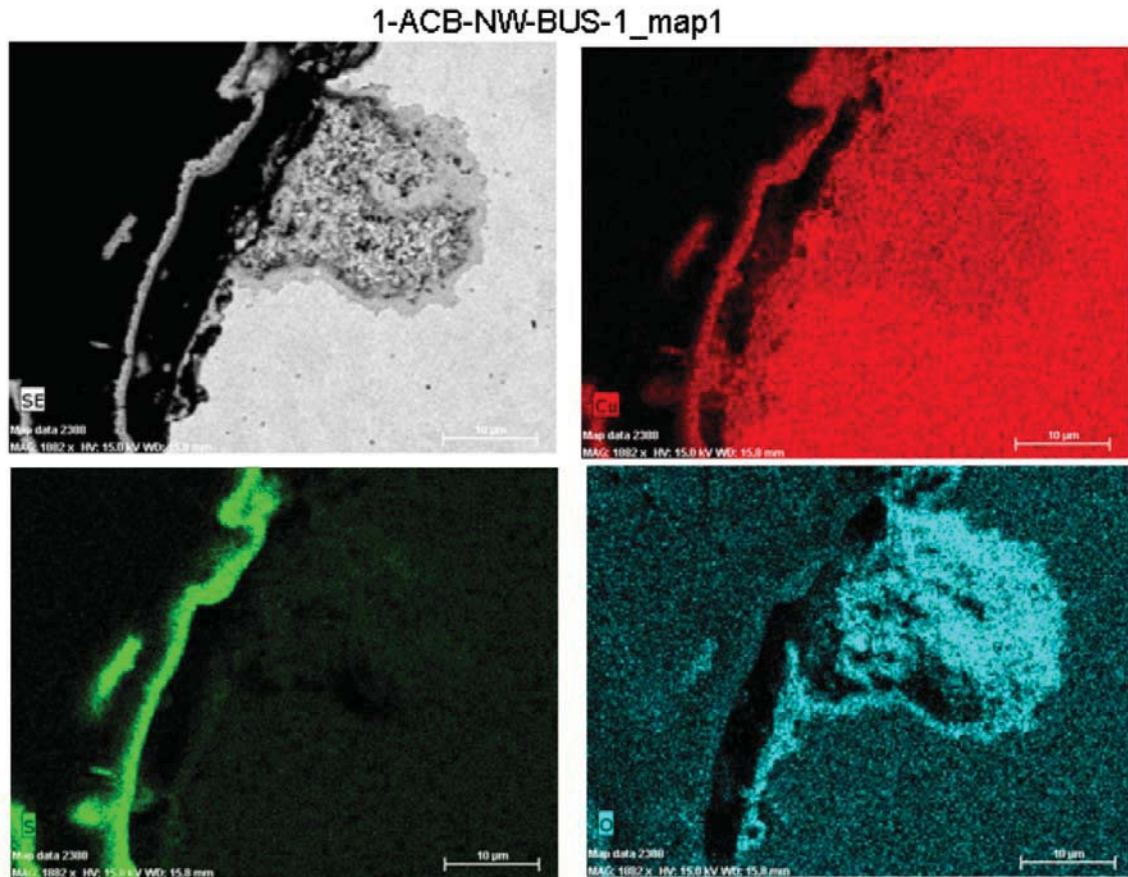
1-ACB-NW-BUS-1\_map2

Part	Figure Number	Comments	Thickness (microns)
1-ACB-NW-BUS-1	Figure 26	Stranded wire Large pit	26.7
1-ACB-NW-BUS-1	Not shown	Stranded wire Flaked off layer + tight layer	6.3
1-ACB-NW-BUS-1	Not shown	Stranded wire “divot” growth	6
1-ACB-NW-BUS-1	Not shown	Stranded wire Wide pit with upper layer that appears to have growth under it	21.7
1-ACB-NW-BUS-1	Figure 27	Stranded wire Wavy layer with wide pit	8.5
1-GR-NW-1	Figure 18	Outer layer with what appears to be growth underneath	11.4
2T-RS-HW1	Not shown	Blister growth	16.4
2T-RS-HW1	Not shown	Blister growth	25.7
2T-RS-HW1	Not shown		26.2

Elemental maps for the neutral wire are shown in Figure 26 and Figure 27. A continuous sulfide film can be seen, with subsurface attack of the base metal which is typical of copper sulfidation reactions. In the void formed in the base metal, oxidation has occurred, filling the cavity with copper oxide and/or copper sulfate.

Figure 26. EDS map of wire cross section showing oxygen in “pocket. The elemental maps for Cu (red), S (green), and oxygen (blue) are shown.

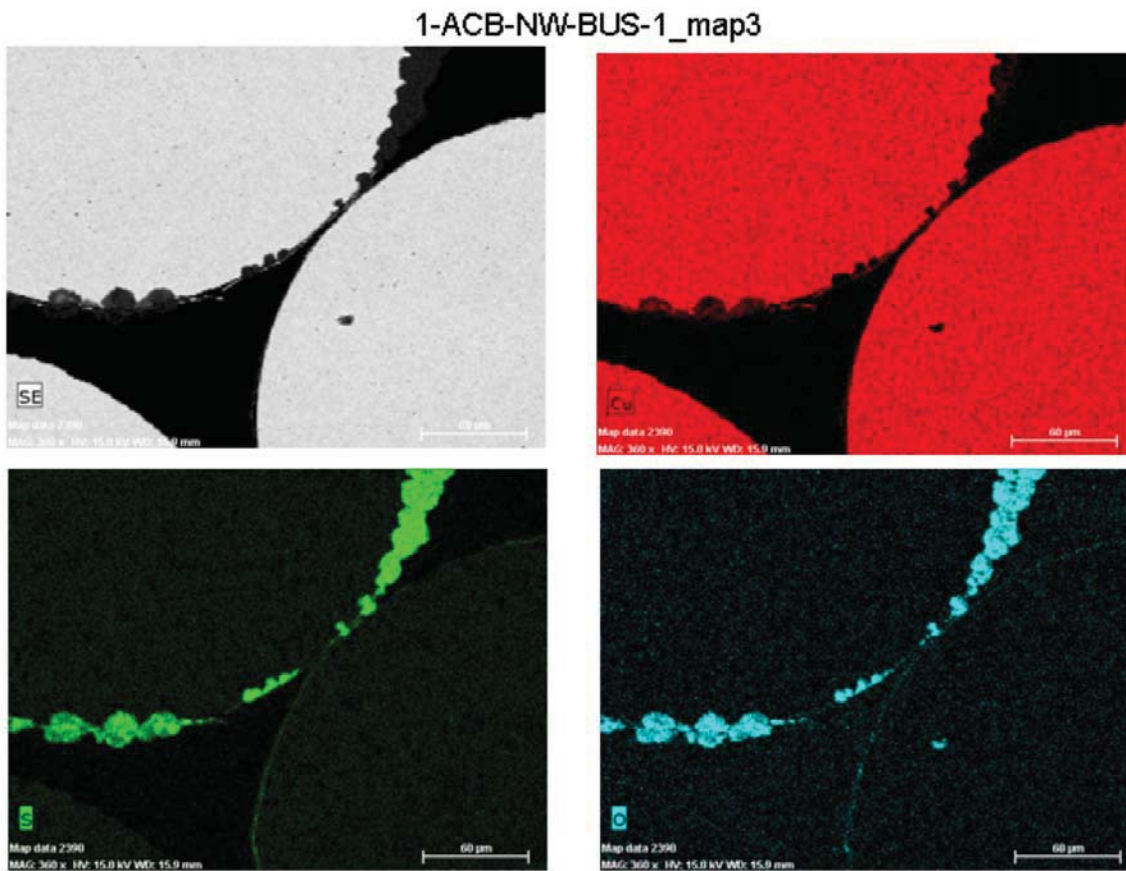
Figure 28 shows elemental maps taken on the stranded wire from the AFCI that was attached to the load center bus. All of the strands of wire are covered with a sulfide layer.

Figure 28. Elemental maps taken on cross section of the neutral wire from the arc-fault circuit breaker from Circuit 1. The image on the left is an SEM image of the area being analyzed. The elemental maps for Cu (red), S (green), and oxygen (blue) are shown.

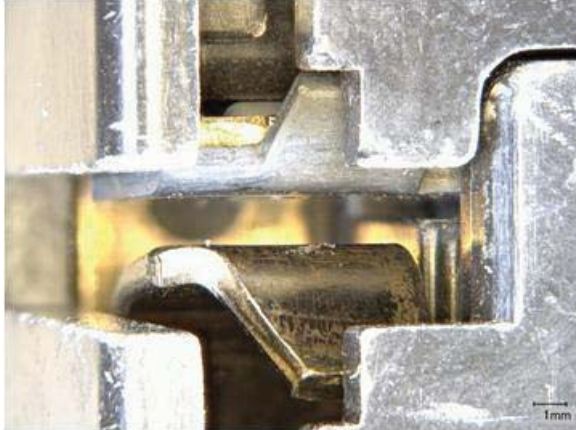
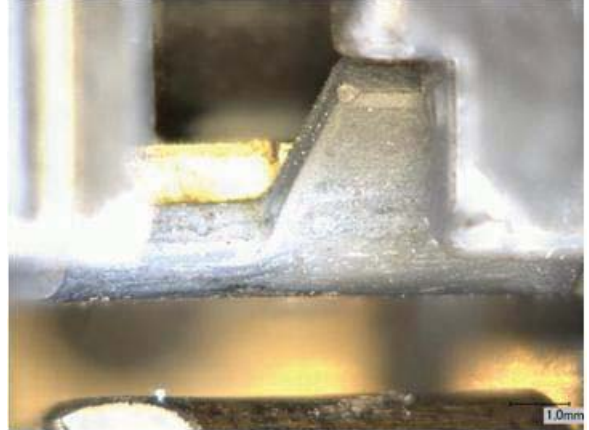
Figure 29 shows optical images of the contact surfaces of the standard circuit breaker from Circuit 1. Corrosion of the upper contact is visible. The lower contact appears to be plated, or constructed of a different material. It did not exhibit extensive corrosion.

Figure 29. Optical images of the contacts in the standard circuit breaker in Circuit 1.

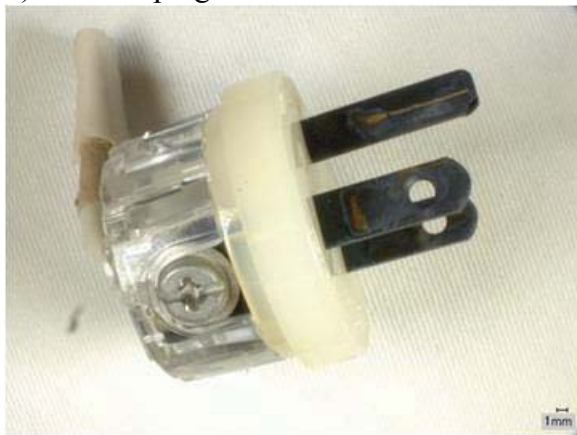
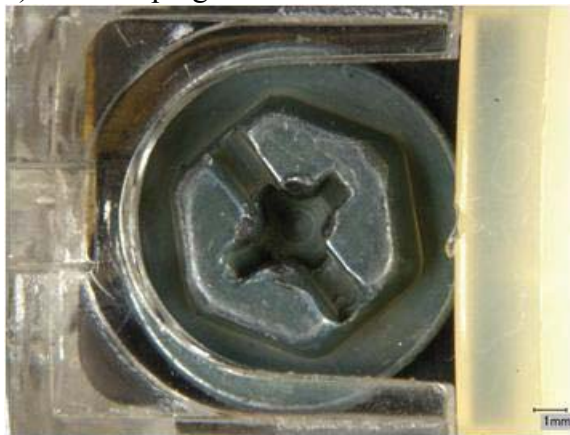
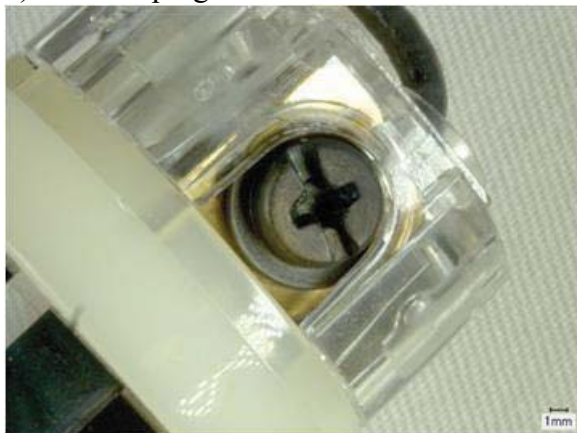
Figure 30 shows images of the plug used to connect the standard receptacle to the GFCI receptacle in Circuit 1. Note that the contact surfaces exhibit corrosion, even when inserted into the socket. Also, note that there are areas of contact that prevented or reduced the attack of the base metal.

Figure 30. Optical images of the plug used to connect the standard receptacle to the GFCI receptacle in Circuit 1. The prongs and screws are blackened relative to those on a new, as-received, unexposed plug.

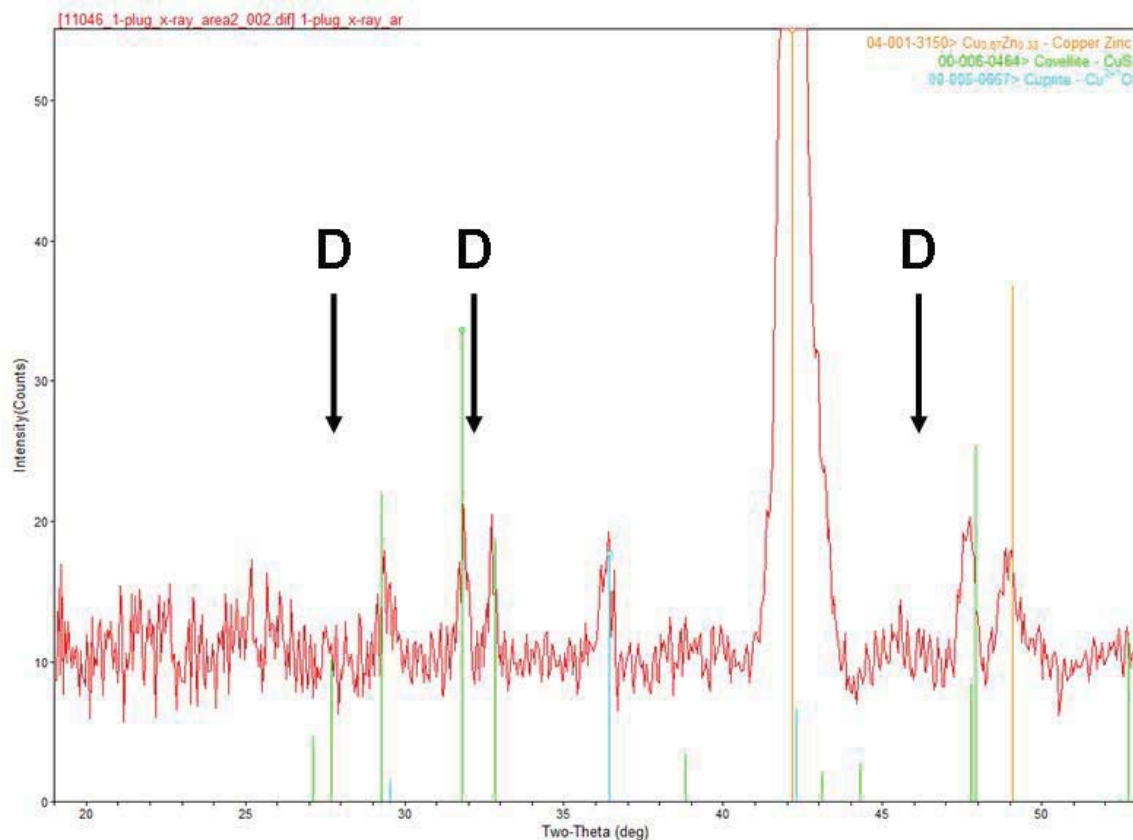
Corrosion product was scraped from the “hot” prong of the plug and analyzed by XRD, and an *in situ* spot was analyzed by  $\mu$ XRD. These tests detected that the base metal is a copper-zinc alloy and revealed the presence of a covellite ( $\text{CuS}$ ) copper sulfide phase. Additional phases detected only by XRD include: copper sulfate hydroxide hydrate and copper zinc sulfate hydroxide hydrate (Ktenasite), whereas, only cuprite  $\text{Cu}_2\text{O}$  was detected by  $\mu$ XRD. Lack of full cross-validation of XRD and  $\mu$ XRD is expected due to the differences in counting statistics and sampling area. The  $\mu$ XRD spectrum is shown in Figure 31 and illustrates the peaks attributable to the covellite, cuprite, and copper-zinc alloy. The figure is also labeled with the approximate locations where a digenite copper sulfide phase would be detected.

Figure 31.  $\mu$ -XRD data for ground prong of plug from Circuit 1, showing cuprite (blue), covellite (green), and copper/zinc (orange) peaks observed and labels where digenite (D) peaks would occur, if present.

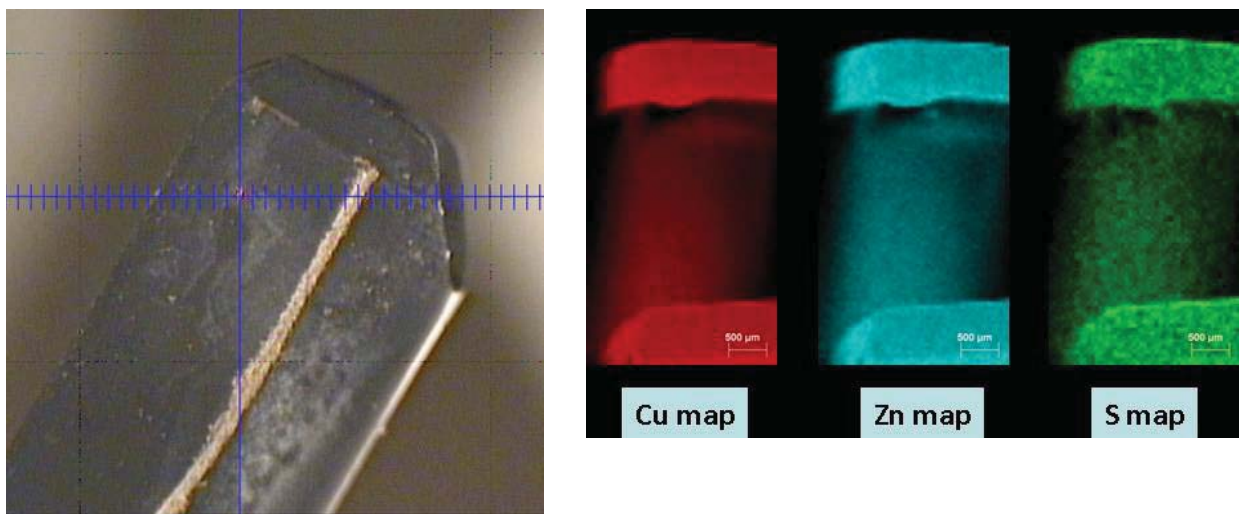
A copper-zinc alloy was detected for the ground prong of the plug by XRF analysis, and the elemental map, Figure 32, shows that the sulfur coverage is uniform within the tested length (approximately 2.5 mm) near the prong end.

Figure 32. Photo of one side of ground prong and XRF element maps of ground prong of grounded plug. XRF images taken “end-on” of full prong.

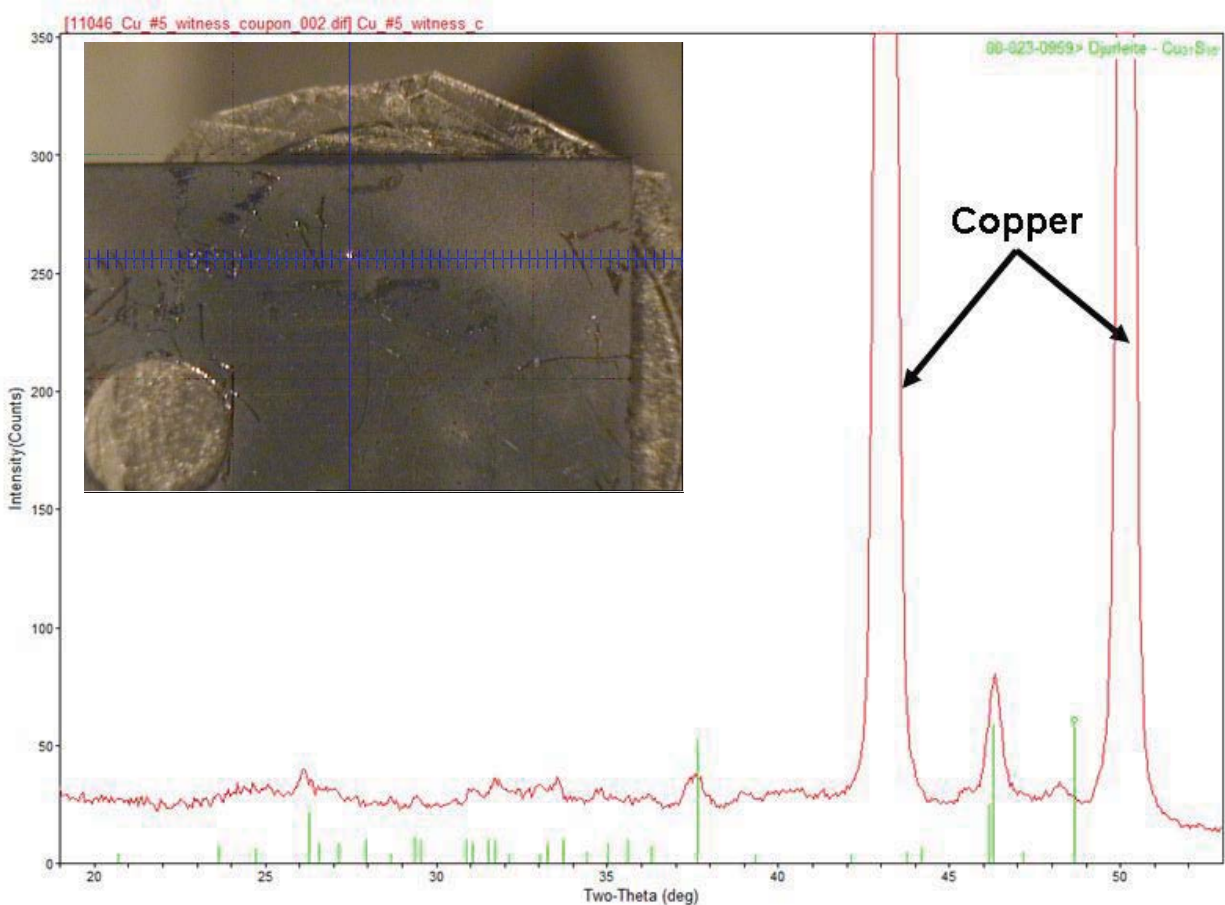
XRD of scraped powder and *in situ*  $\mu$ XRD both detected the copper sulfide phase known as “djurleite” ( $\text{Cu}_3\text{S}_{16}$ ) as the predominant corrosion product observed on copper witness coupon No. 5. Data for the  $\mu$ XRD, along with the image indicating the location of the analysis, are shown in Figure 33. The image shows the copper witness coupon (which has a small hole for mounting, which was not used in these tests) on top of the metal instrument sample holder. The grey to bluish-black appearance of the sample is consistent with the appearance of djurleite. Both XRD and  $\mu$ XRD techniques verify also that the witness coupon is pure copper.

Figure 33. Video image (inset) showing location of  $\mu$ XRD analysis and  $\mu$ XRD data for witness coupon No. 5, showing labeled copper and djurleite peaks (green).

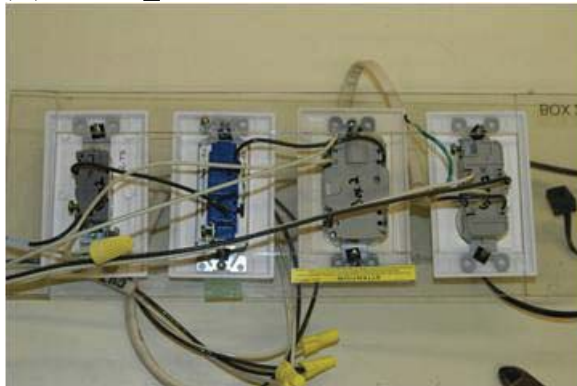
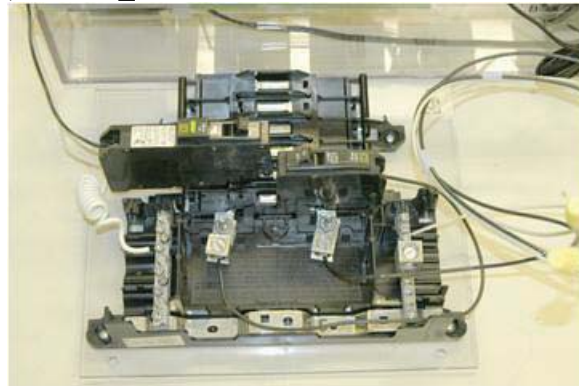
Figure 34 shows optical images of the load center and the back side of the components for Circuit 2. Parts from the rocker switch and the GFCI receptacle were selected for cross section SEM and X-Ray analysis (see Table 5).

Figure 34. Photographs of the electrical components tested in Circuit 2. The view from the bottom (left image) shows how the system was wired electrically. The image on the right shows the load center.

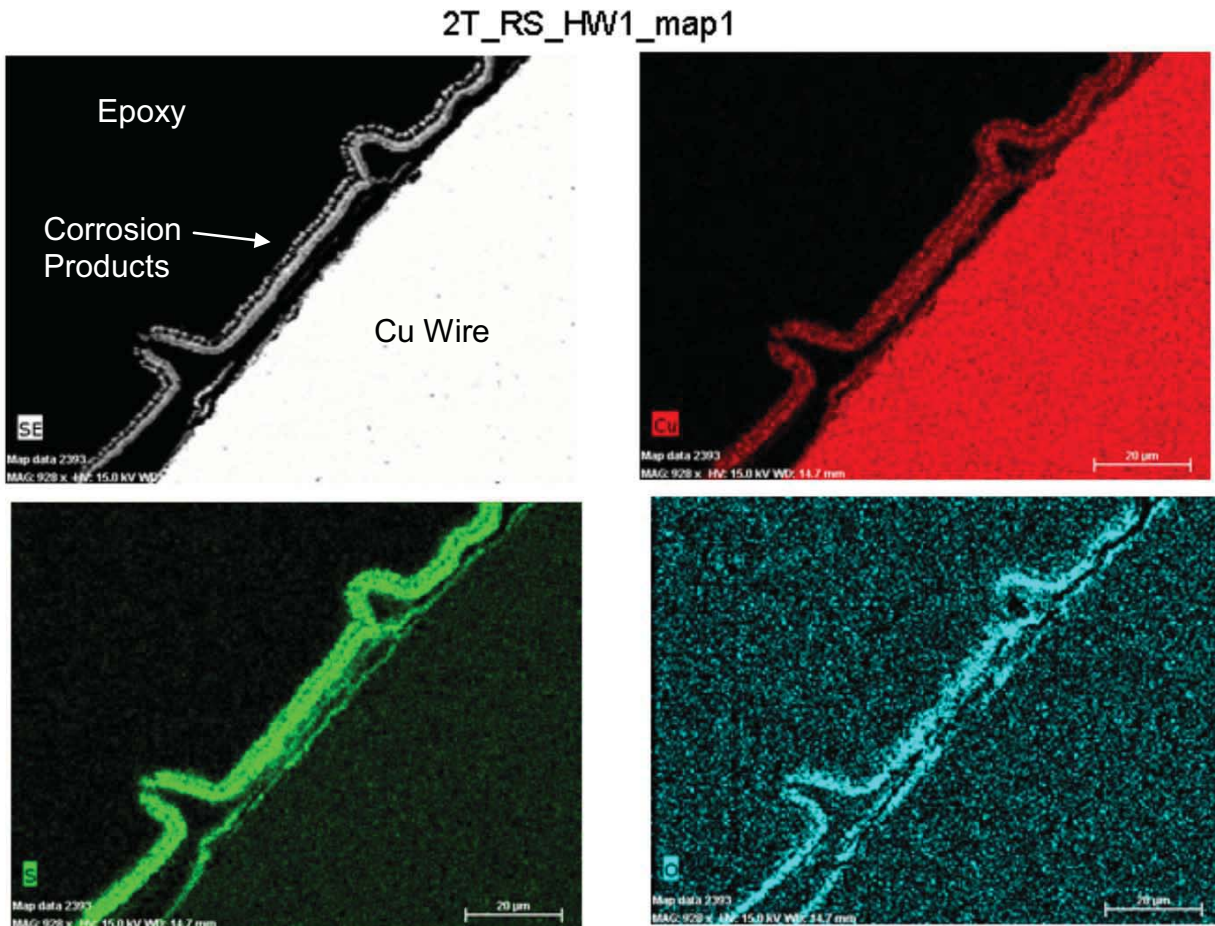
Figure 37 shows the elemental maps of the wire shown in Figure 36. The corrosion product consists of a layer of copper sulfide, with a thinner layer of either copper oxide or possibly copper sulfate.

Figure 37. Elemental maps from the rocker switch hot wire (cross sections) in Circuit 2. The upper left image is an SEM image identifying the area being analyzed. Three maps are shown for Cu (red), S (green), and oxygen (blue).

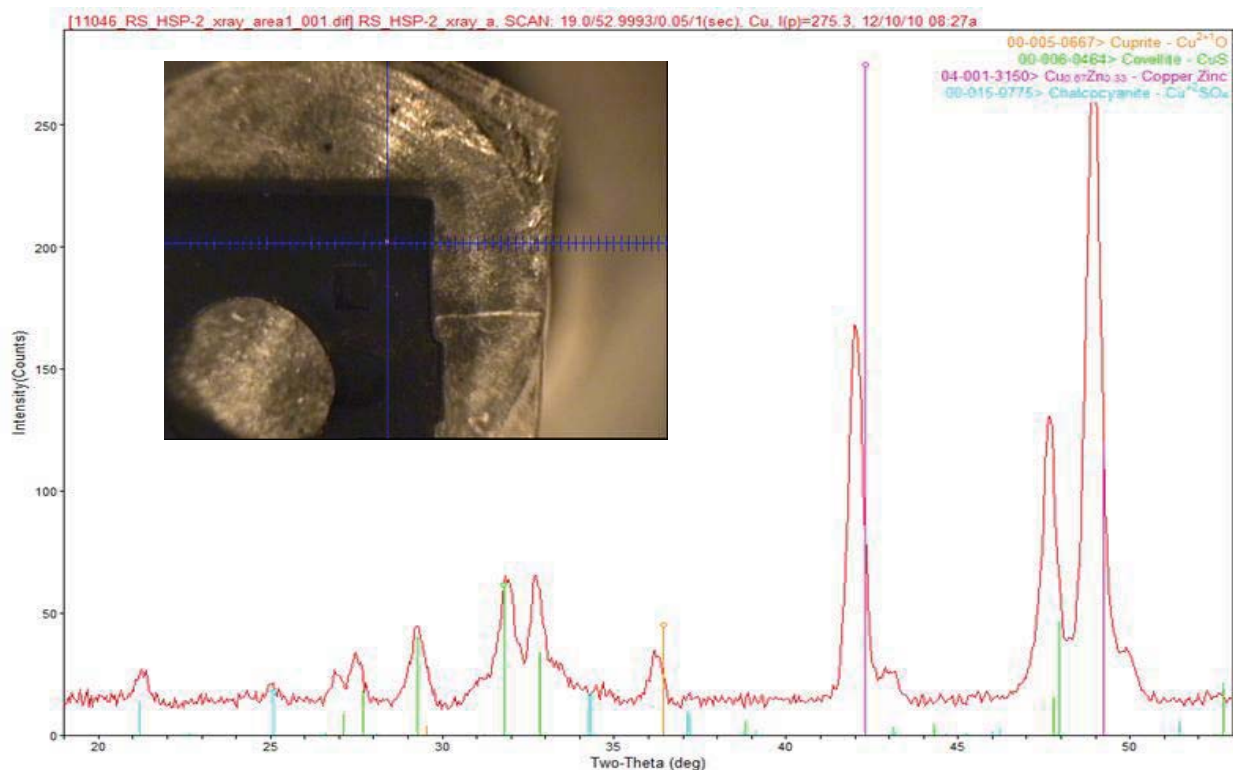
XRD analysis of scraped powder from this contact plate detected the same phases that were detected in the powder scraped from the Circuit 1 plug: covellite, copper sulfate hydroxide hydrate, Cu-Zn sulfate hydroxide hydrate (Ktenasite), and a copper-zinc alloy (as the  $\text{Cu}_{0.67}\text{Zn}_{0.33}$ ).  $\mu\text{XRD}$  analysis was also consistent with that of the Circuit 1 plug, detecting cuprite, covellite, and copper-zinc alloy. Additionally a chalcocyanite phase ( $\text{CuSO}_4$ ) was detected *in situ* on this part. The location of sampling and  $\mu\text{XRD}$  data are shown in Figure 38. The large metal piece behind the sulfidated (black) part is the instrument sample holder.

Figure 38. Video image (inset) and  $\mu\text{-XRD}$  data for 2-RS-HSP-2 (contact plate), showing cuprite (orange), covellite (green), and copper/zinc (purple), and chalcocyanite ( $\text{Cu}^{2+}\text{SO}_4$ -light blue) peaks observed.

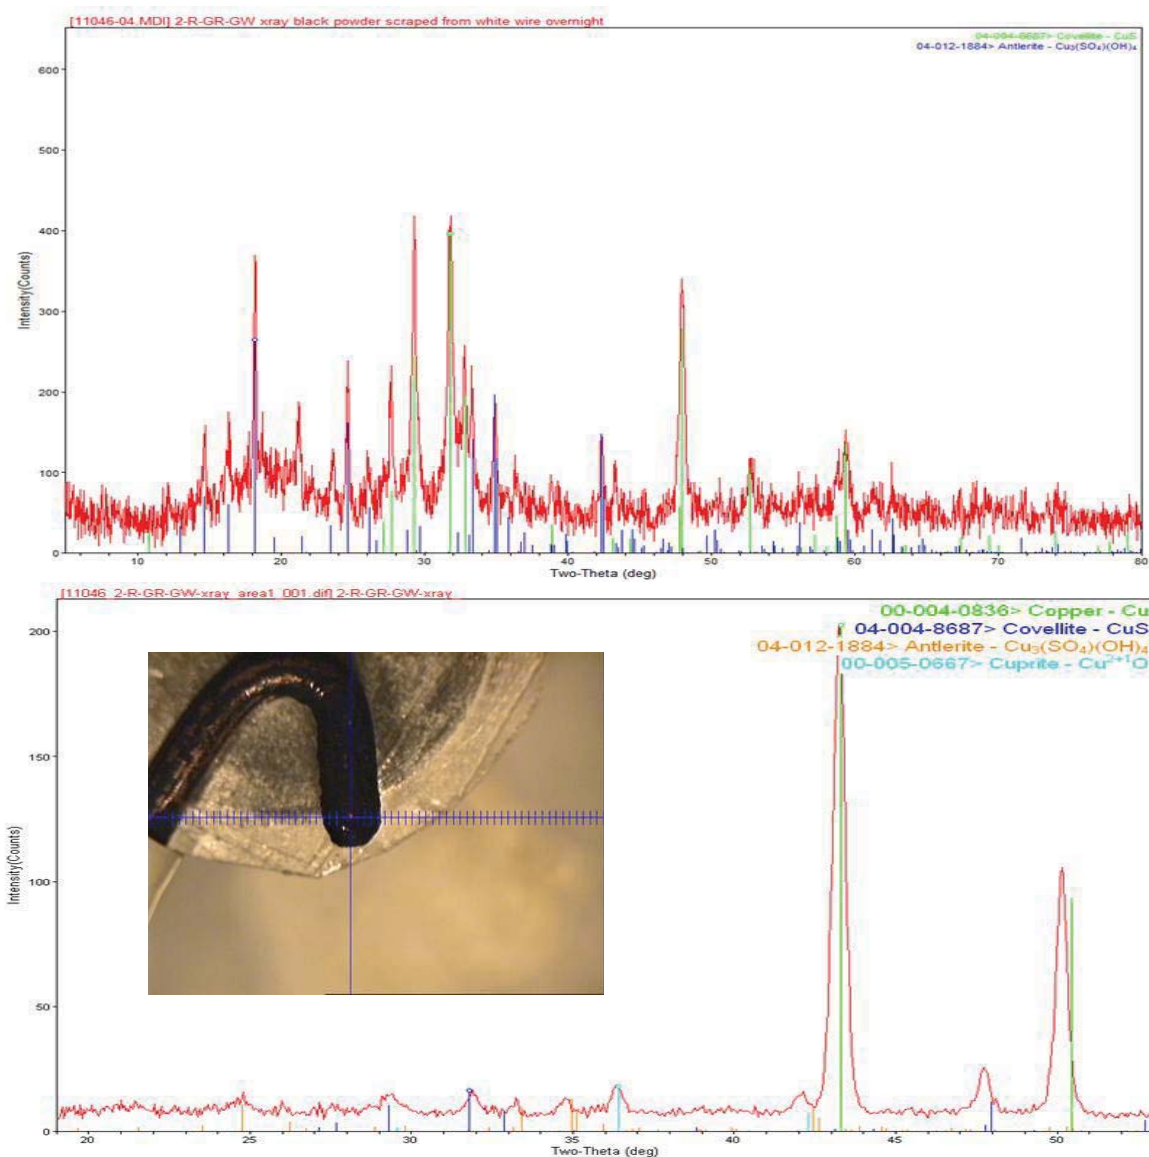
XRD analysis of black powder scraped from the wire surface (top, Figure 39) and  $\mu$ XRD *in situ* of the ground wire (bottom, Figure 39) of the GFCI component of Circuit 2 detected covellite ( $\text{CuS}$ ) and the antlerite copper sulfate hydroxide phase ( $\text{Cu}_3(\text{SO}_4)(\text{OH})_4$ ). In addition, the  $\mu$ XRD data shows copper oxide (cuprite) and copper metal.

Figure 39. XRD data (top) for powder scraped from wire 2-R-GR-GW showing covellite (green) and antlerite (blue), and  $\mu$ -XRD data (bottom) showing antlerite (orange), cuprite (light blue), covellite (dark blue), and copper (green) peaks.

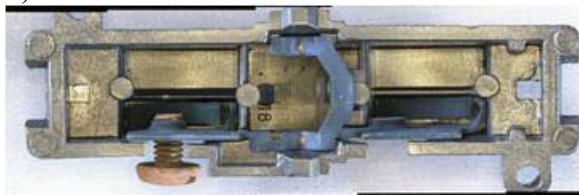
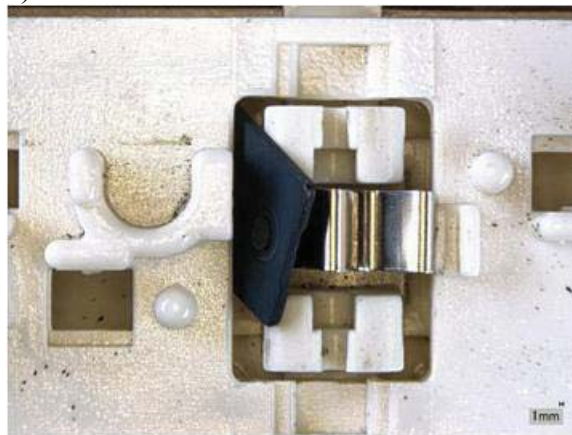
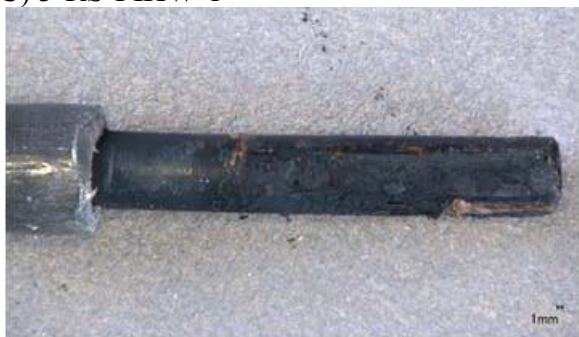
Figure 40 shows optical images for the rocker switch from Circuit 3. The case was removed to reveal the interior components. As with other components, it appears that the case provides little or no protection against the corrosive gasses. Both interior and exterior components exhibit corrosion. The bottom two images show both sides of the hot wire. In this case, the wire was connected to the push-in contact. Corrosion of the wire surface was less nonuniform, but it essentially covered the entire surface other than the contact point.

Figure 40. Optical images of the rocker switch and hot wires from Circuit 3.
