# **Report on Study of Electrical Component Corrosion Related to Problem Drywall**

Division of Electrical Engineering  
Directorate for Engineering Sciences  
U.S. Consumer Product Safety Commission

March 2011

## **Report on Accelerated Corrosion Studies of Electrical Components**

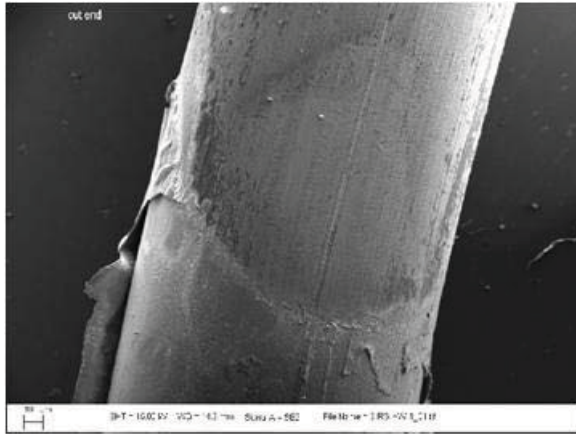
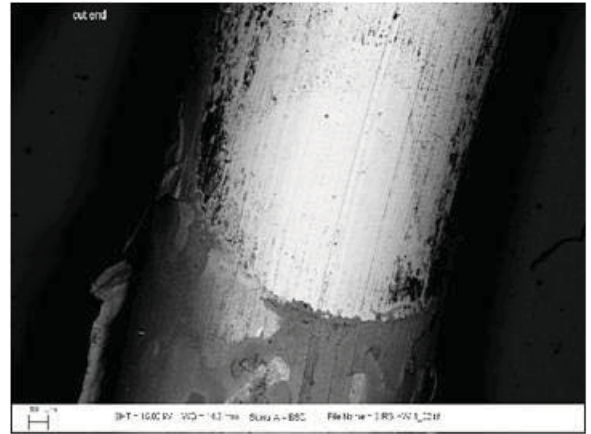
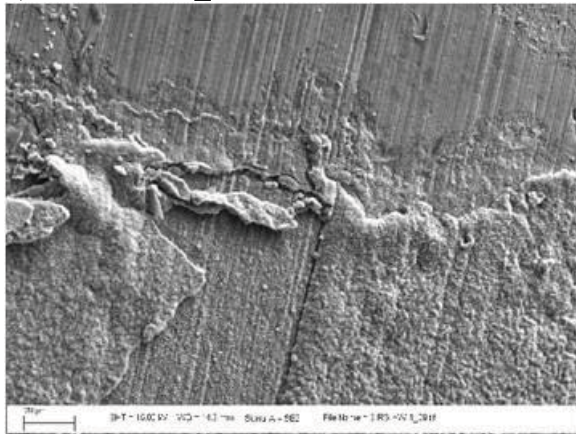
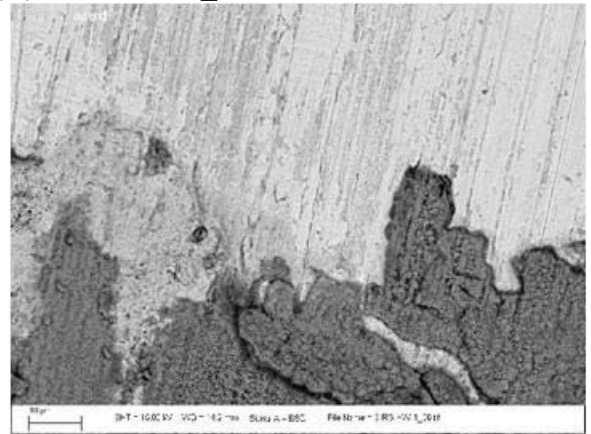
Figure 41 shows SEM images of the hot wire from the rocker switch. The figures on the left are secondary electron images that show topography. In this case, the insulation was removed next to the corroded area. The images on the right are back-scattered electron images. In these images, brightness is a function of the atomic number of the element on the surface. The bright area in the top of the image represents bare copper exposed by the removal of the insulation; the lower portion of the picture is darker and represents the sulfide layer (*i.e., copper has a higher/larger atomic number than sulfur*). These images show that sulfidation of the copper stops where the insulation protects the underlying copper. Figure 42 shows the elemental maps associated with this location. Clearly, the insulation protected the underlying copper from sulfidation because the top of the elemental maps showing the region of the wire that was covered with insulation shows no sulfur.

Figure 41. SEM images of the hot wire from the rocker switch in Circuit 3. The figures on the left are secondary electron images, which show topography. The images on the right are back-scatter images. In these images, brightness is a function of the atomic number, with higher brightness indicating elements of higher atomic number.

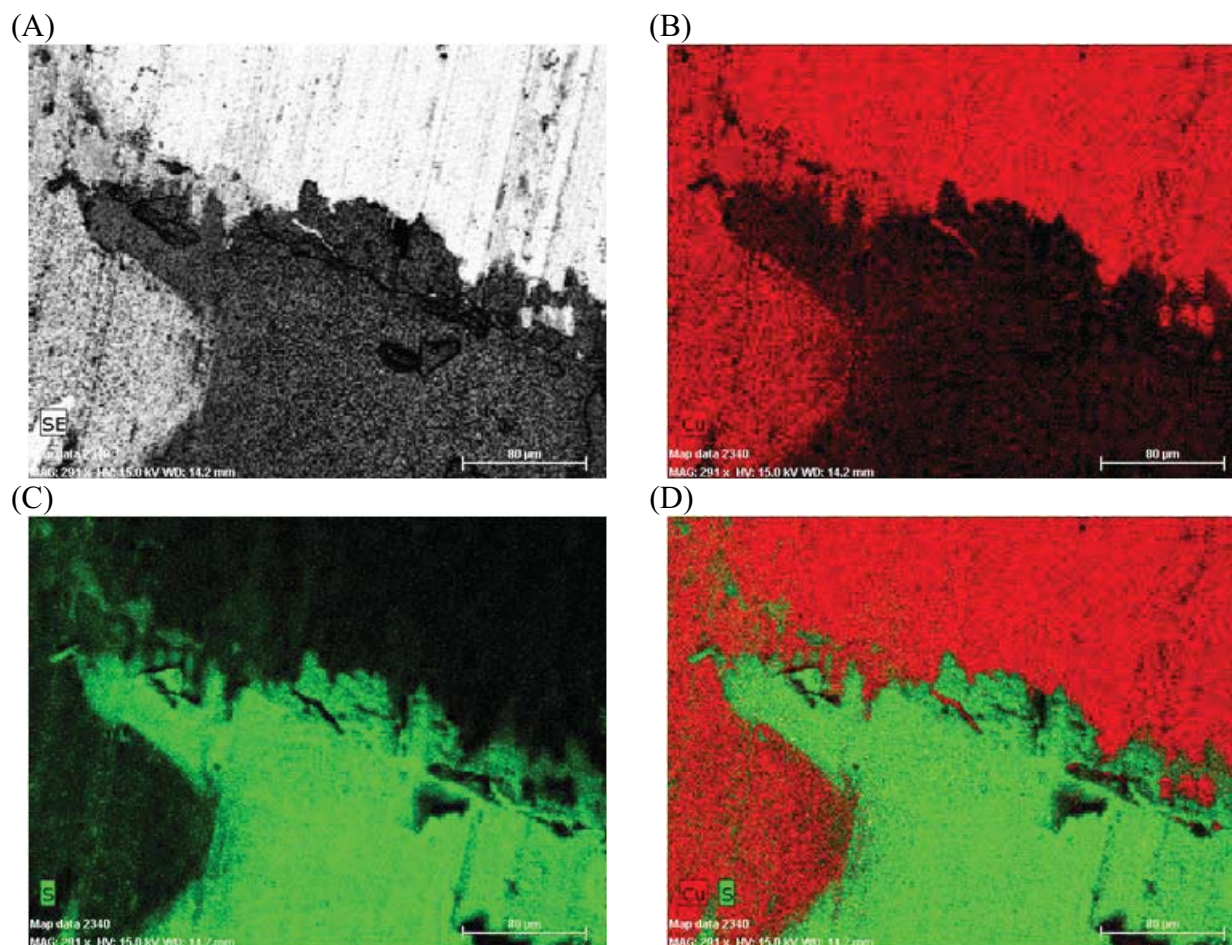
Figure 42. EDS elemental maps of the hot wire from the rocker switch in Circuit 3. Images include A the SEM image, (B) a copper map (red), (C) a sulfur map (green), and (D) a combined copper/sulfur map (red and green).

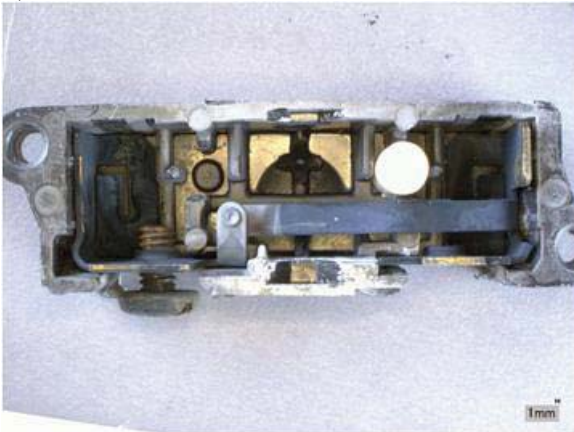
(A) 3-TS-insides-1

Figure 43. Optical images of the toggle switch in Circuit 3. The figure on the left shows the inside of the switch. Note the extensive corrosion product on some of the components. The image on the right is of the hot wire connected to the toggle switch (screw side).

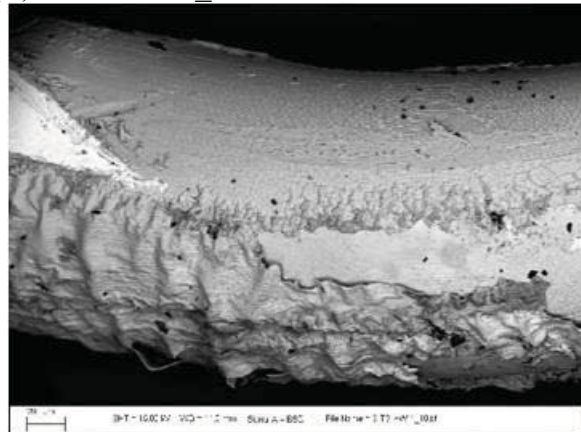
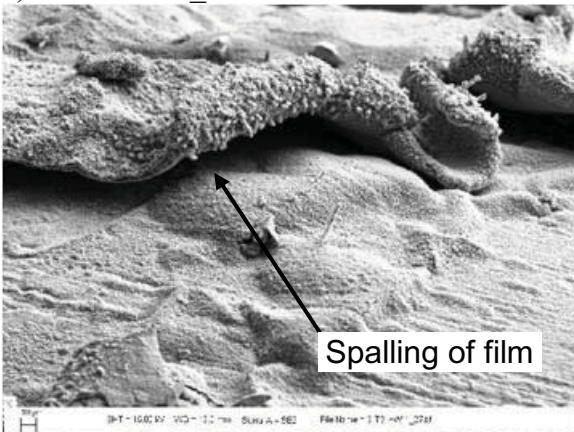
Figure 44 shows SEM images of the hot wire from this component. The top two images are back-scattered electron images and show the presence of bare Cu at a contact point (light region). The corrosion product film structure/morphology is similar to that found on other components, exhibiting layering, buckling, and spalling.

Figure 44. SEM images of the hot wire from the toggle switch in Circuit 3. Note the spalling of the corrosion product film. The contact areas can be seen in the upper two images (bright areas) where the contact shielded the surface from the corrosive gasses.

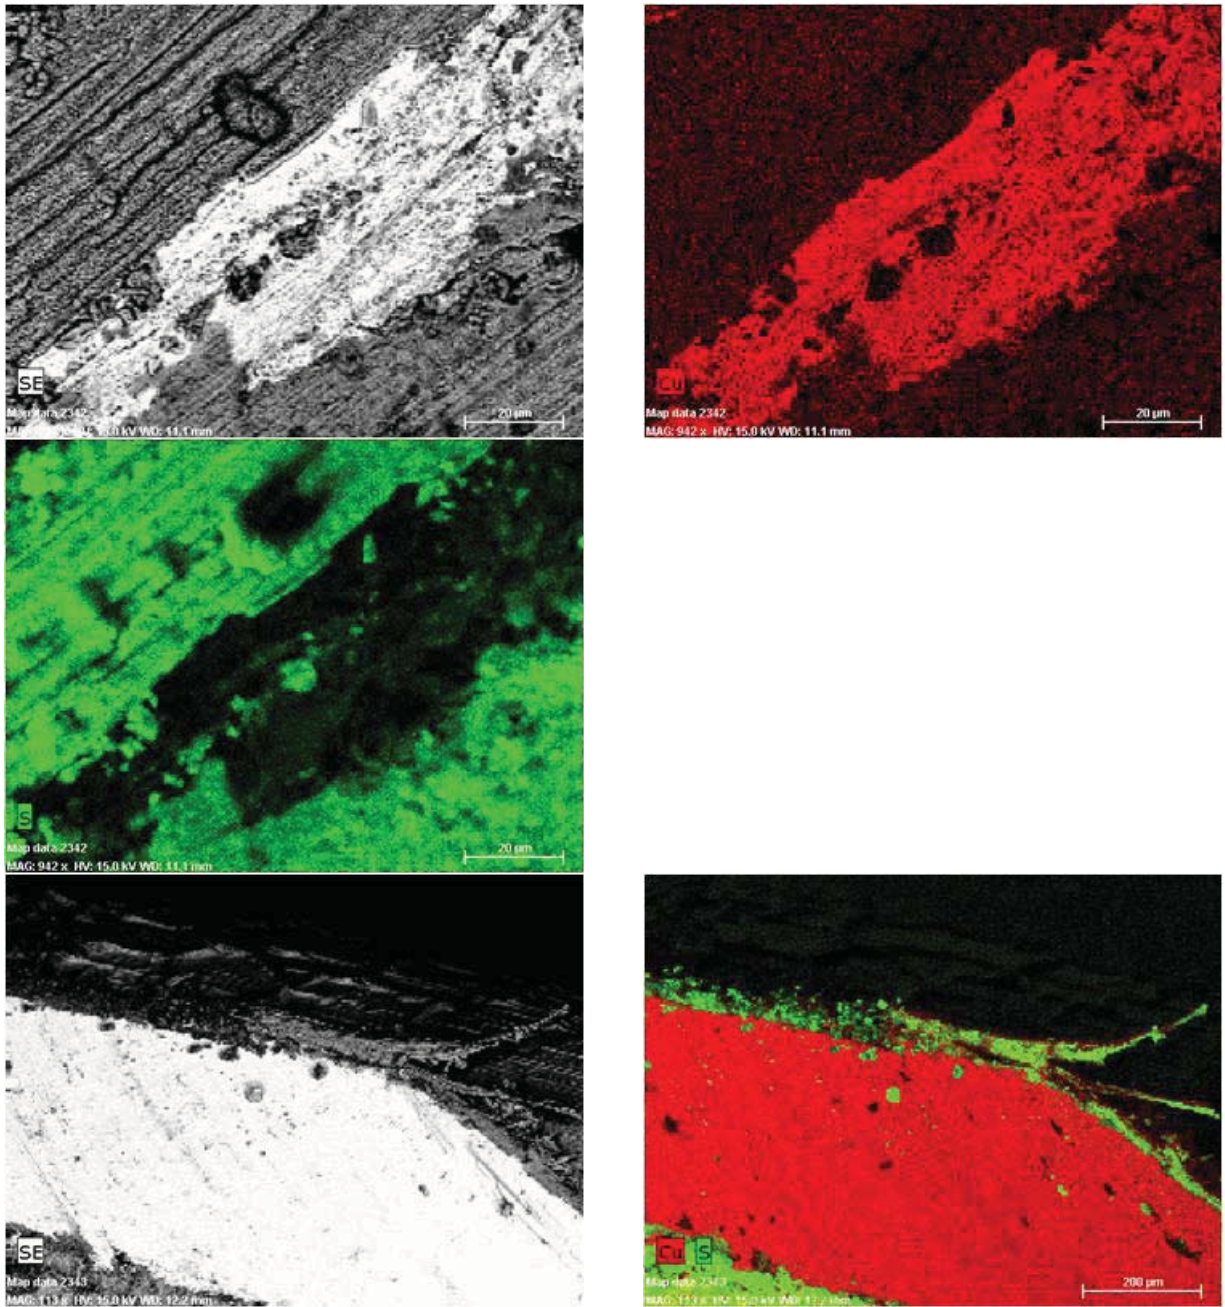
Figure 45 shows EDS elemental maps of two areas of the hot wire from the toggle switch. Copper is shown in red, and sulfur is shown in green. These images are consistent with the SEM images and show the presence of bare Cu at the contact points.

Figure 45. SEM images and EDS elemental maps of the hot wire from the toggle switch in Circuit 3. Sulfur is shown in green, and copper is shown in red.

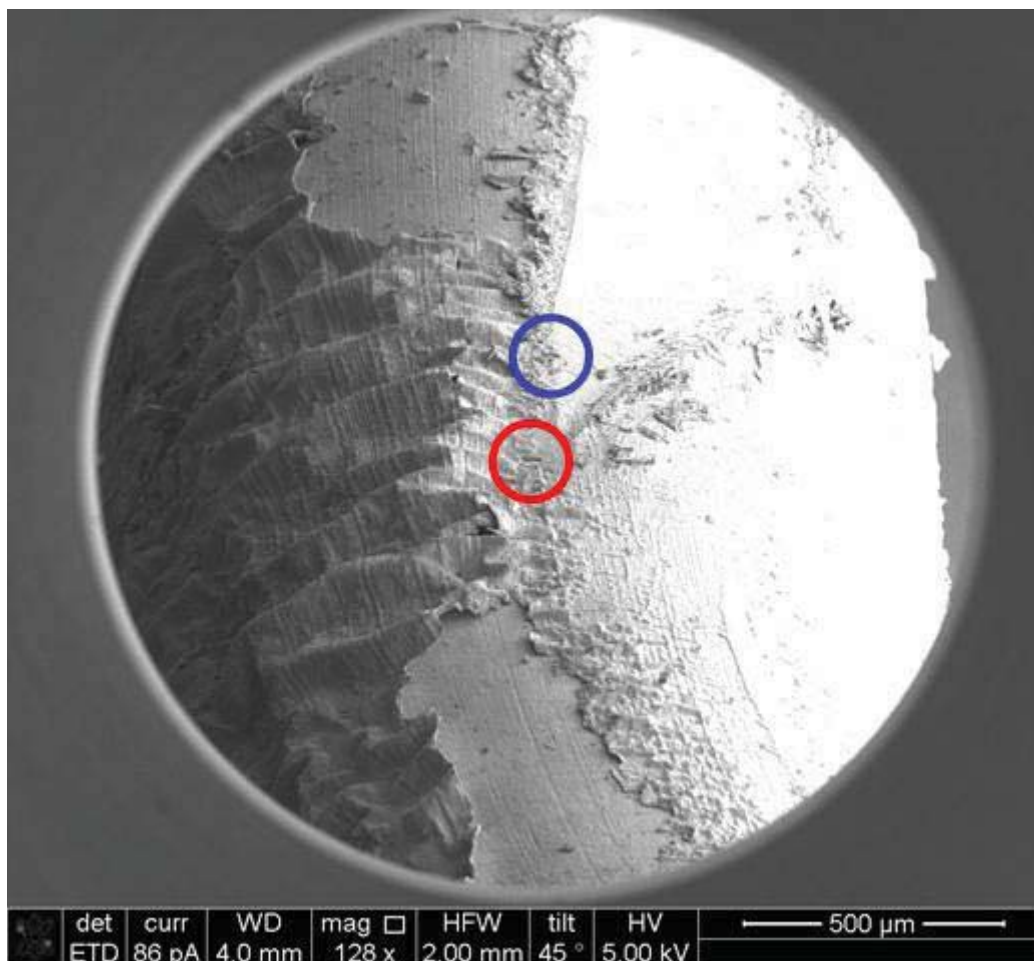
potentially less damaging to the surface layers; however, it is time consuming; therefore, only limited FIB analyses were performed. Figure 46 shows a low magnification view with circles indicating locations of two FIB cuts. Since this is a very low magnification, the instrument aperture is observed as the wider circle. The bright area in the upper right, is the area where the screw made contact with the wire and appears to be free of corrosion product.

Figure 46. Low magnification FIB image of hot wire from toggle switch (3TS-HW-1), showing location of FIB cuts (red designated as “Section 1” and blue designated as “Section 2”) into corrosion product film.

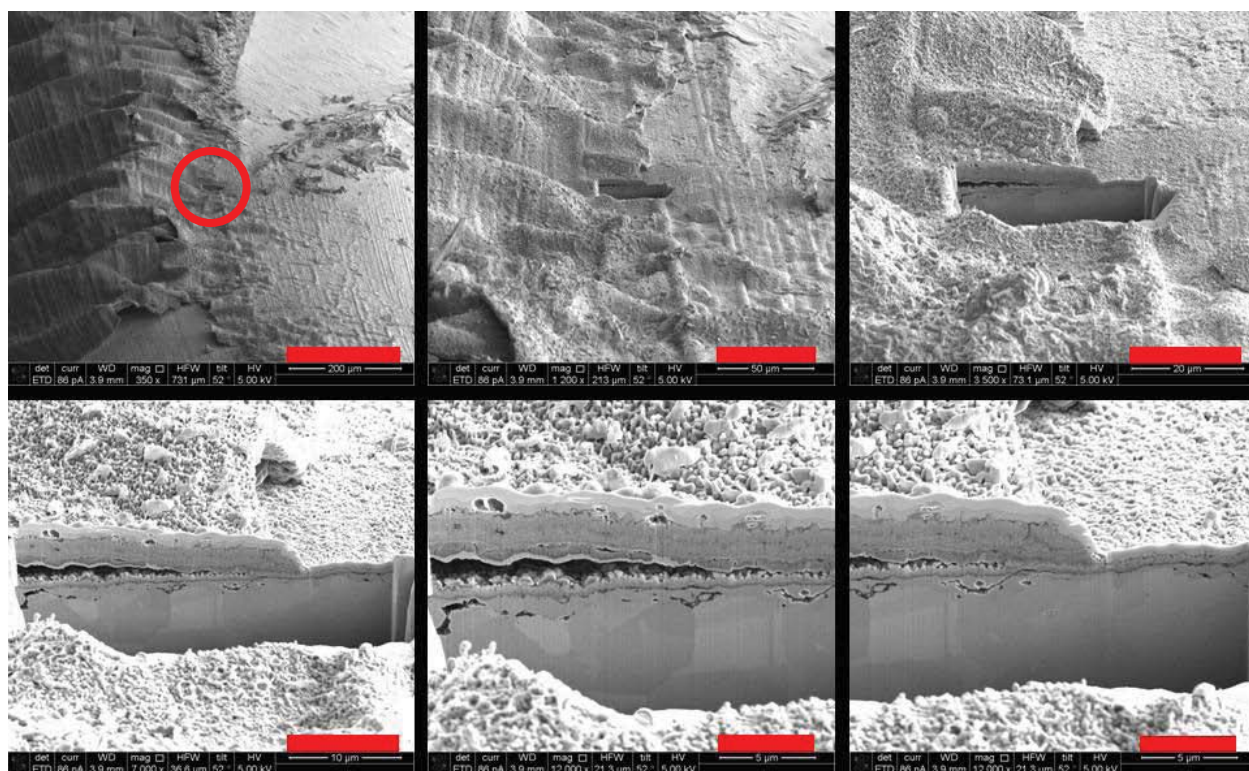
Figure 47 shows SEM images of the FIB cut designated as “Section 1,” indicated by the red circle in the previous figure, at increasing magnifications (350 to 12,000X magnification). This FIB cut is approximately 50 microns from the nearest portion of the wire contacted by the screw. The middle top image illustrates wavy features of the corrosion product observed in SEM cross sections of other samples. The right top and lower left images illustrate an abrupt edge of the wavy growth that appears to have smaller features, suggesting flaking and regrowth of the corrosion product. The middle lower and right lower images show closer views of the corrosion layer and the varying gap between the wire and corrosion product. This is consistent with crosssection observations of other wires.

Figure 47. FIB cuts into 3-TS-HW-1 “Section 1” (see Figure 46) with scale bars at 200 (350X), 50, 20, 5, and 5 (12,000X) microns, respectively.

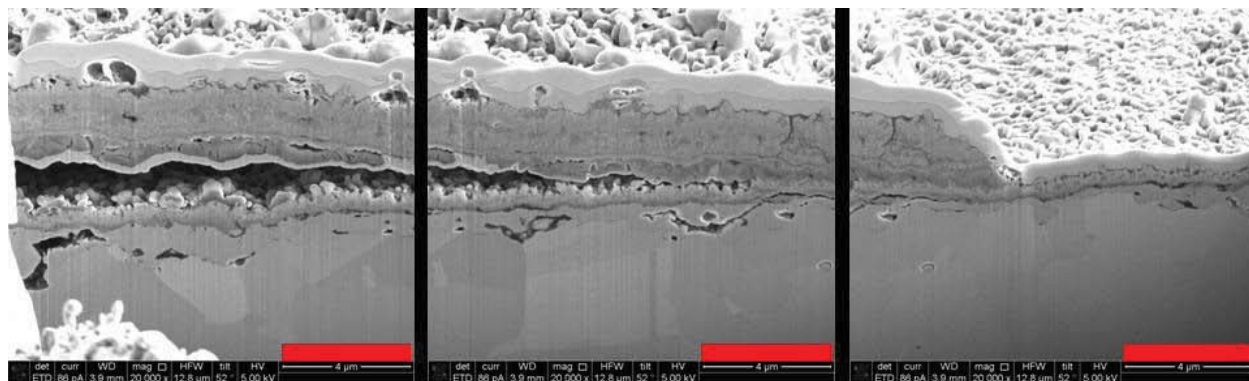
Figure 48 shows three images at the same magnification (20,000X) of the edge of the FIB cut. The copper wire is at the bottom, the varying contrast areas are consistent with solid copper. Some pitted areas are observed along with roughened product growth underneath the upper layer of corrosion. The bright white top layer is the platinum layer deposited on the sample to preserve features.

Figure 48. FIB cuts into 3-TS-HW-1 “Section 1” (see Figure 46) with scale bars at 4 microns each.

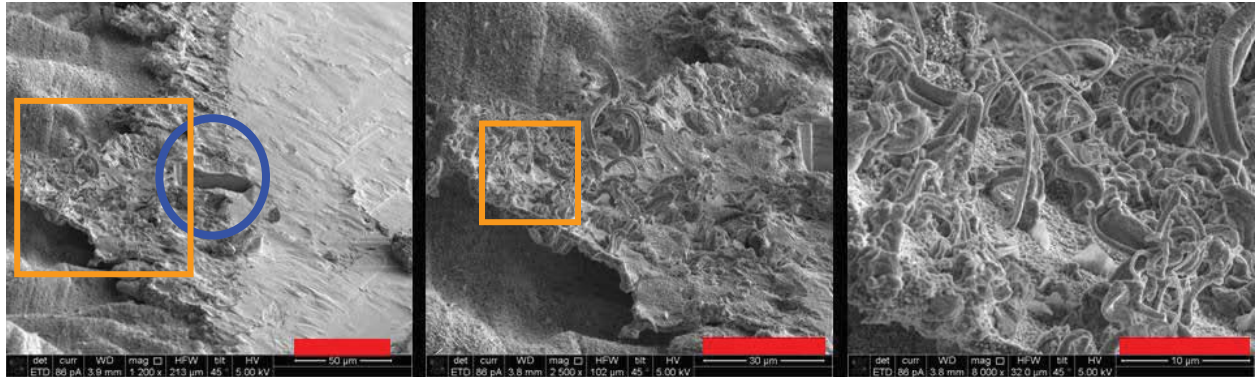
Interesting growth morphologies were seen in all samples, which included needles and other features. One example, with needle and spiral-like growths, observed near the FIB cut is shown

in Figure 49 at various magnifications. On the left is a wider view of “Section 2,” indicated with the blue circle. The orange box indicates the approximate area of the middle image, while the orange box in the middle image indicates the approximate area of the image on the right.

Figure 49. FIB cuts into 3-TS-HW-1 “Section 2” (see Figure 46) with scale bars at 50, 30, and 10 microns, respectively.

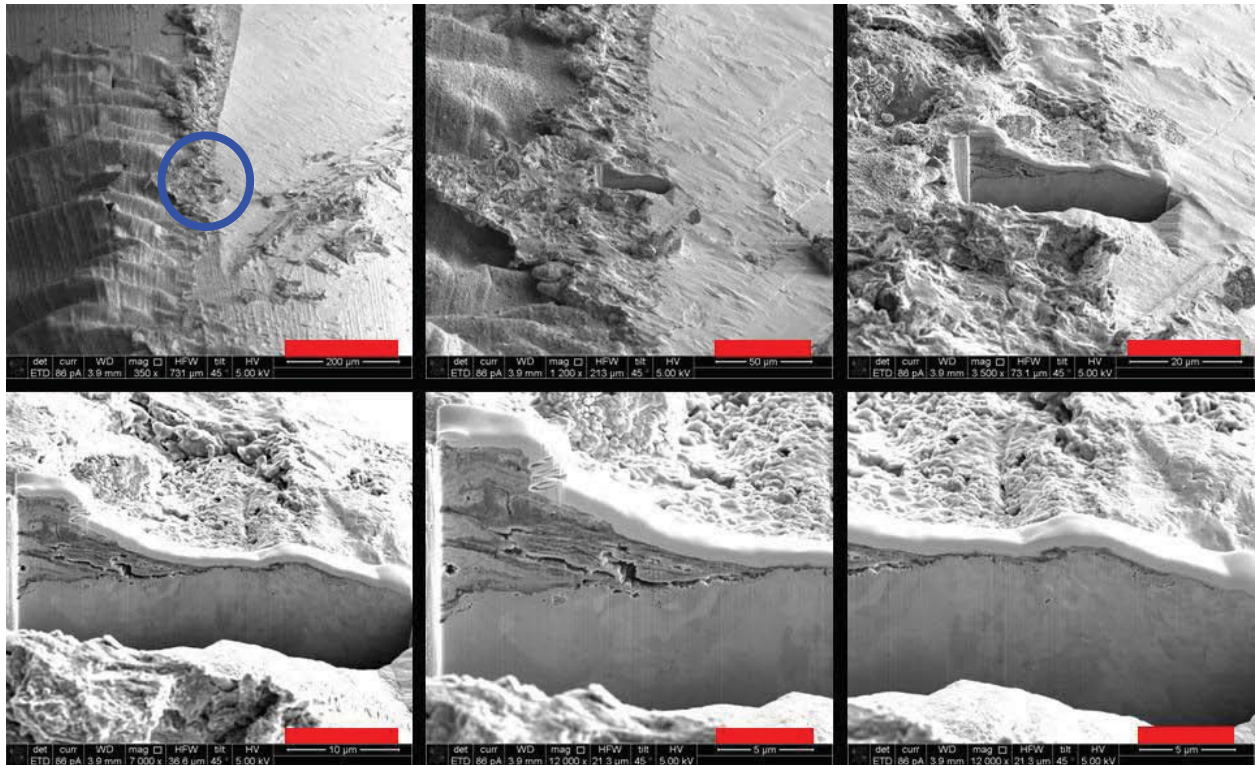
A closer look at the cross section of corrosion growth revealed by the FIB cut designated as “Section 2” is shown in Figure 50. In the top row, a bare copper area is observed to the upper right of the images, the area underneath the screw. The lower row shows higher magnification views of the change in the corrosion growth thickness from left to right.

Figure 50. FIB cuts into hot wire from Circuit 3 toggle switch (3-TS-HW-1) “Section 2” (see Figure 46) with scale bars at 200, 50, 20, 10, 5, and 5 microns, respectively.

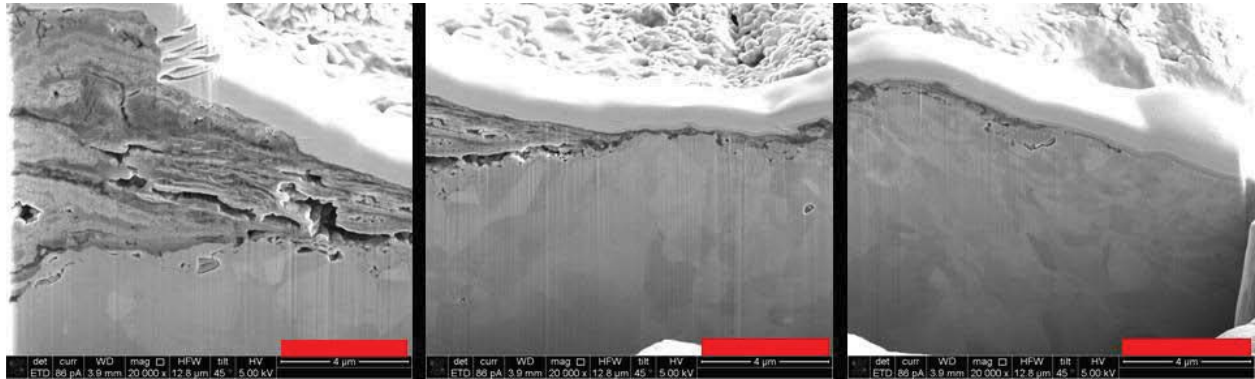
Figure 51 contains a series of SEM images across the FIB cut at 20,000X magnification. Layering and pitting is observed; moving from left to right and closer to the contact point of the screw, the overall corrosion thickness transitions from approximately nine microns to significantly less than one.

Figure 51. FIB cuts into 3-TS-HW-1 “Section 2” (see Figure 46) with scale bars at 4 microns each (20,000X).

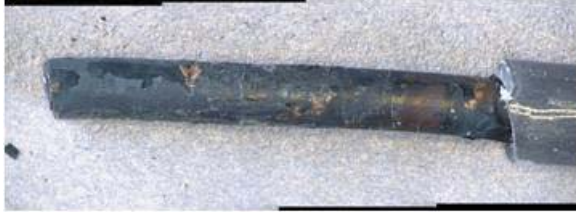
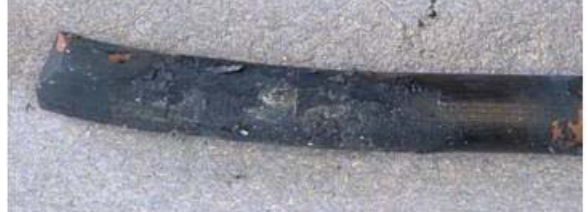
Figure 53 shows optical images of the hot wires (push-in contacts) from the standard receptacle from Circuit 3. These results are consistent with previous samples, showing corrosion product across the surface except where the contact was made.

Figure 53. Optical images of wires from the standard receptacle from Circuit 3. Both the (A) hot and (B) neutral wire are shown. Both are “push-in” type contacts.

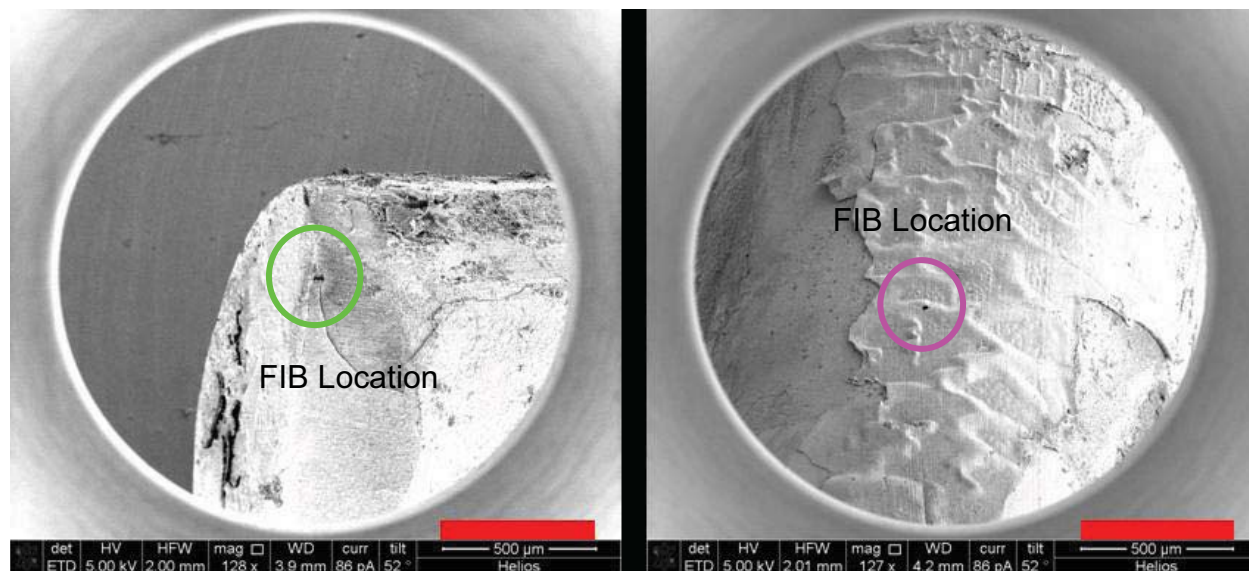
Figure 55. FIB cuts into corrosion product on surface of neutral wire 3-R-PINW-1 with “Section 3” (left) and “Section 4” (right) with scale bar of 500 micron.

SEM images of two FIB cuts (designated as “Section 3” and “Section 4”) on the neutral wire from the push-in connector of the receptacle are shown below at magnifications of 128x and 127x. The aperture of the instrument is observed as the outer view circle due to wide view and low magnification. “Section 3” (left) was cut at the edge of the corrosion product film. Section 4 (right) was cut into an area surrounded by “wavy” corrosion growth.

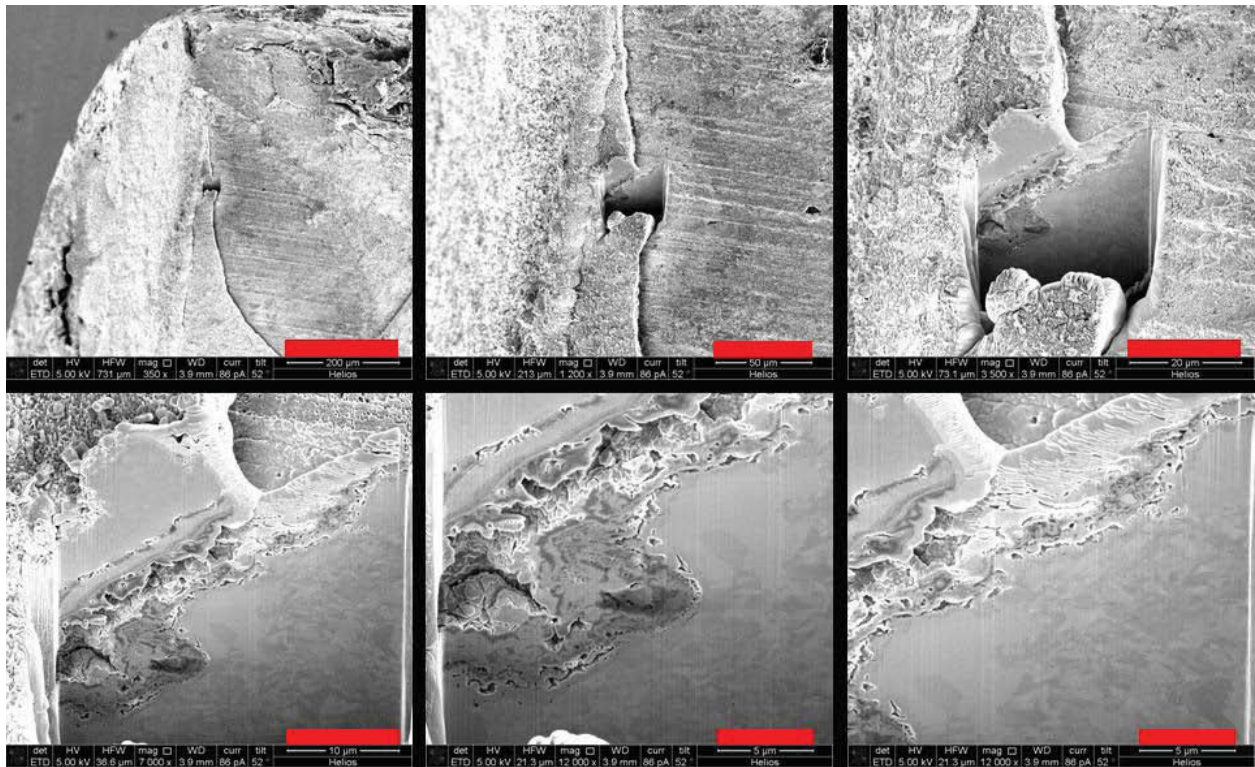
Figure 56. FIB cuts into neutral wire 3-R-PINW-1 “Section 3” (see Figure 55) with scale bars of 200, 50, 20, 10, 5, and 5 microns.

Higher magnification images of “Section 3”, ranging from 350X to 12,000X are presented next (Figure 56) and display varying thickness as well as voiding of the copper below the corrosion product film. The fracture line down the center of the images in the top row shows an area of corrosion product that flaked off.

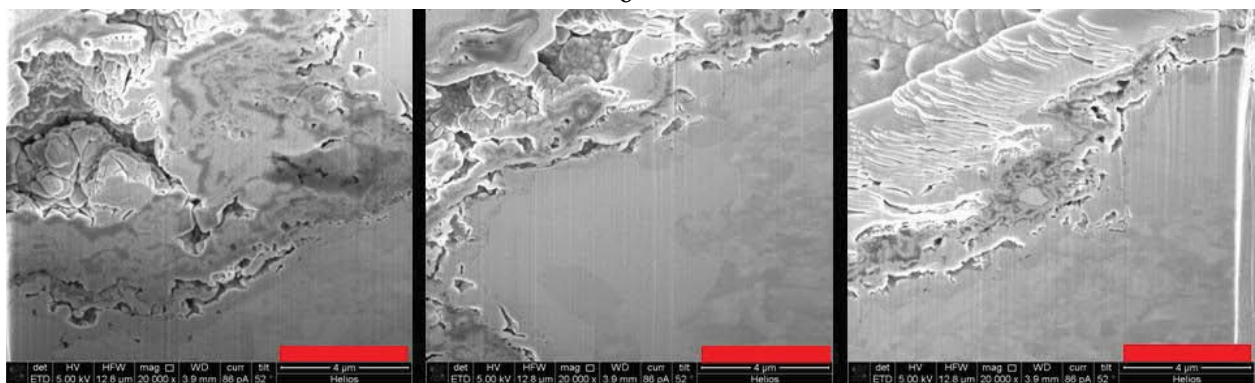
Figure 57. FIB cuts into neutral wire 3-R-PINW-1 “Section 3” (see Figure 55) with scale bars of 4 micron each.

Higher magnification images of the pitting observed in “Section 3” are below (Figure 57); with the thinnest corrosion growth, the platinum FIB coating, and pure copper grains prevalent in the image on the right.

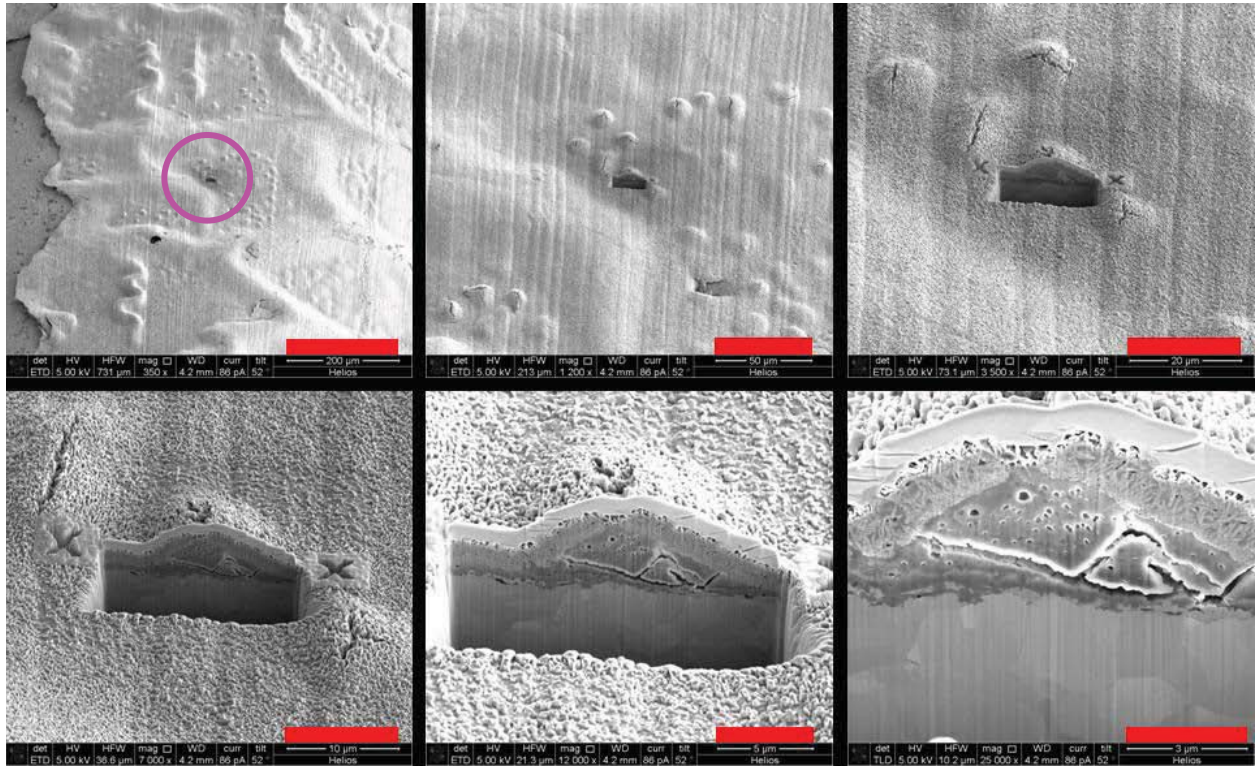
Figure 58. FIB cuts into neutral wire 3-R-PINW-1 “Section 4” (see Figure 55) with scale bars of 200, 50, 20, 10, 5, and 3 microns, respectively.

Higher magnification views of “Section 4” are shown in Figure 58 and illustrate an additional morphology seen in some samples—that of a “bubbling” or blistering of the corrosion product layer. The magnification ranges from 350X to 25,000X. In the lower right image, three different kinds of growth layer are observed—a layer with few voids, a middle layer with multiple voids,

and a third solid layer with what appears to be striated growth. The top-most white layer in the image is the platinum FIB overcoat.

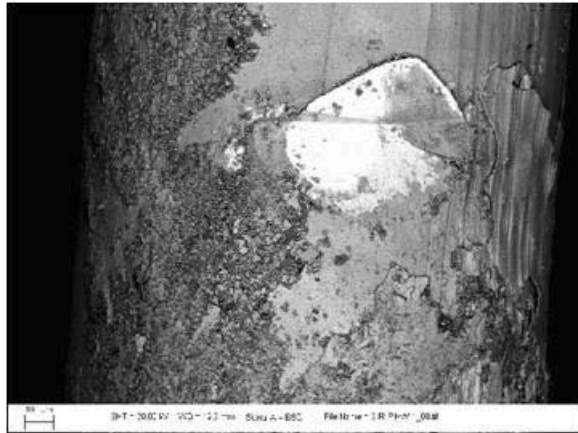
Figure 59. SEM images of the hot wire from the receptacle in Circuit 3. The connection was a push-in connection. The contact point is shown in the image on the left. The image on the right shows a region of a hot wire that was covered by insulation on the bottom.

Figure 59 shows SEM images of the push-in hot wire from the receptacle in Circuit 3. The image on the left shows the contact point. It is clear that the intimate contact between the wire and the receptacle contact prevented sulfidation from occurring in the contact area. The image on the right shows the wire at the interface with the insulation. In this case, the insulation was removed to reveal the wire surface directly beneath the insulation. The fact that bare copper is visible in the region shielded by the insulation suggests that the insulation prevents the pollutant gas from contacting the copper wire.

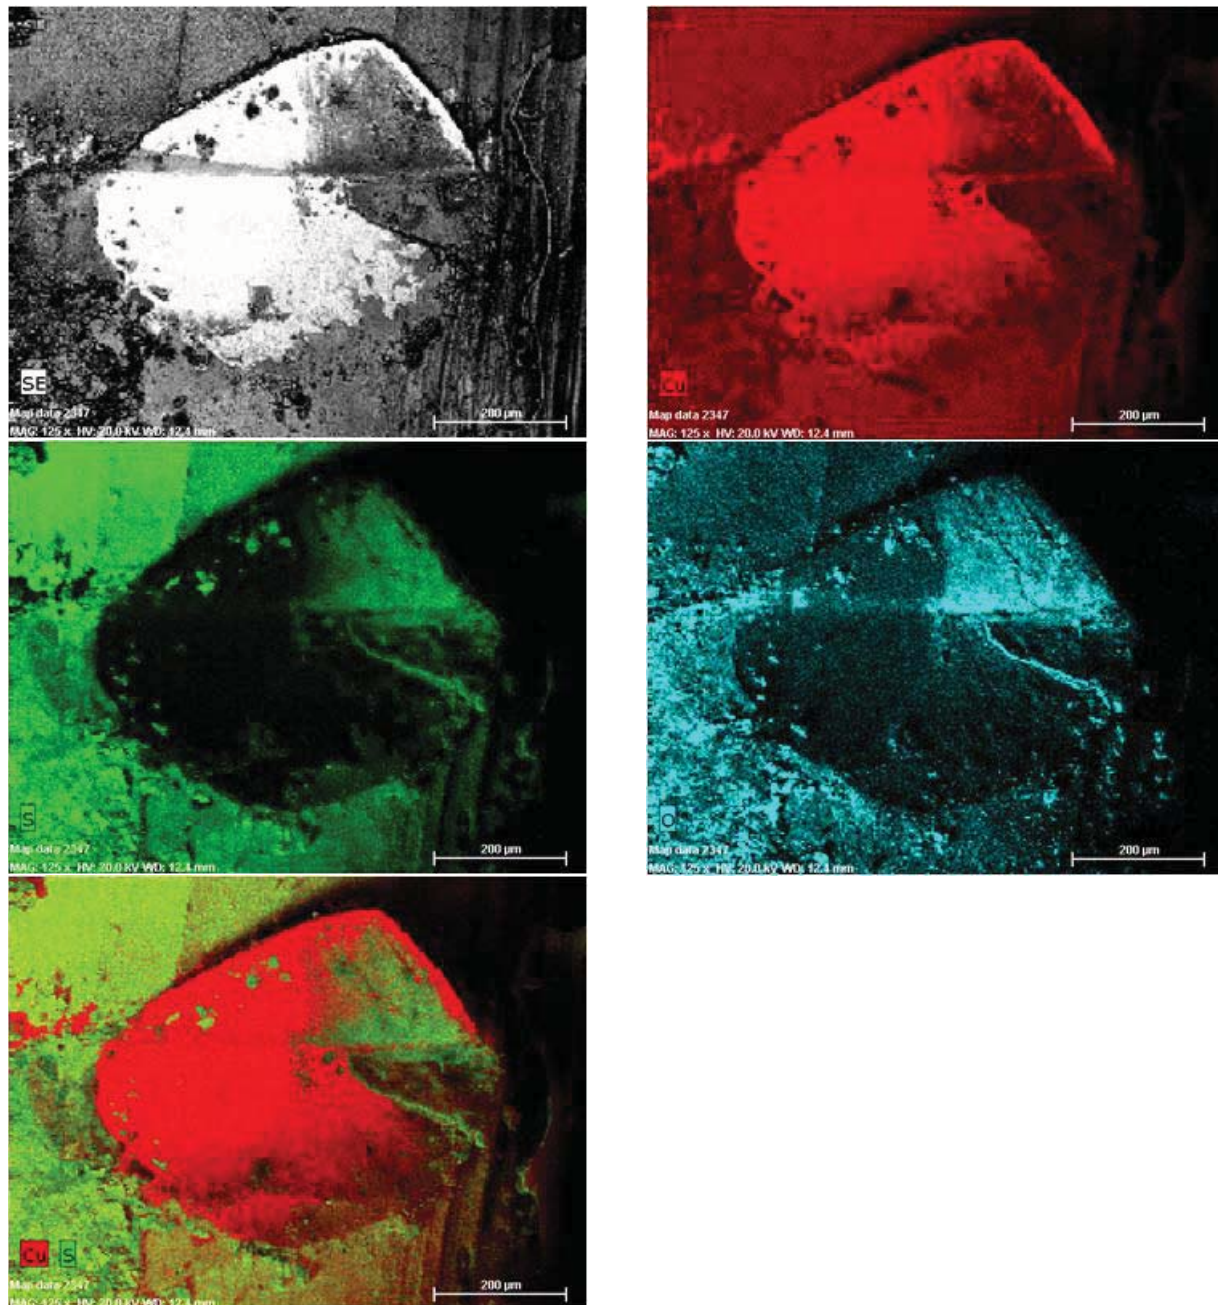
Figure 60. EDS elemental maps of the wire shown in Figure 59. Copper (red), sulfur (green), and oxygen (blue) are shown.

Figure 60 shows the EDS elemental maps from the wire in Figure 59. Copper corrosion products (primarily sulfide with some oxide and/or sulfate) are present on the wire surface, except where the contact was made. In that location, bare copper is visible.

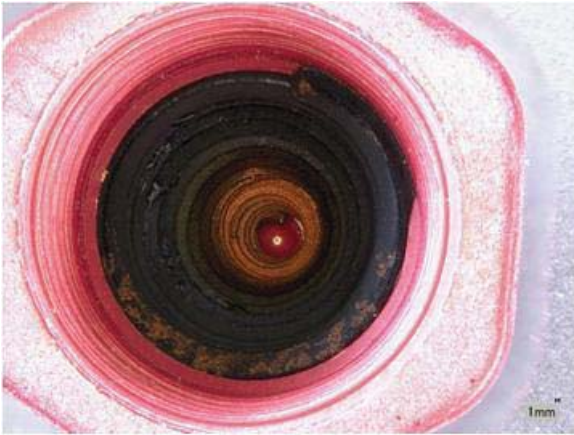
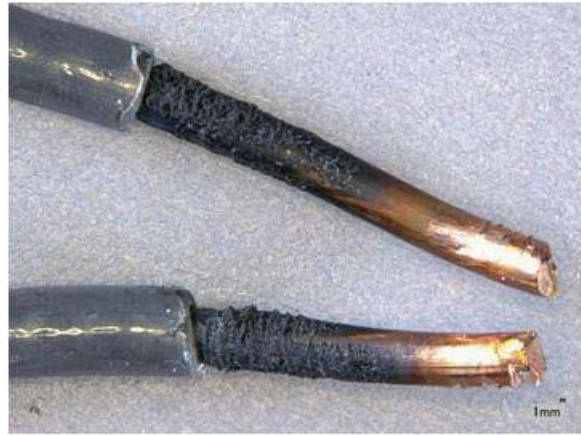
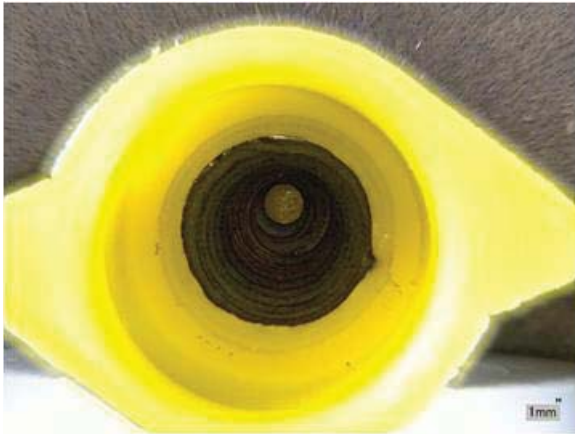
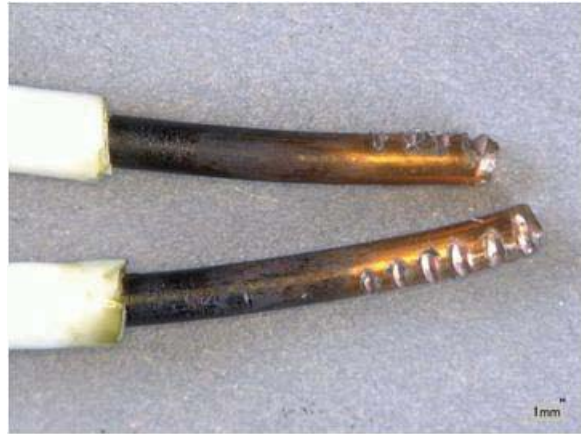
Figure 61. Optical images of twist-on connectors with hot and neutral wires used on the output section of Circuit 2.

Figure 61 shows optical images of twist-on connectors and the associated wires used to connect component assemblies inside the chamber. Corrosion of both the wires and the twist-on connectors was observed. The extent of corrosion decreased with depth into the twist on connector. A thick corrosion product layer was found next to the insulation. The ends of the wires, where protected by the twist-on connector, exhibit bare copper.
